## INDIVIDUAL DATA SHEET

Property Name Stockton Building Property Owner Dr. John Stockton  
Location 113 N. Broadway, Siloam Springs Address P. O. Box 486  
Construction Date 1894 Survey No. 2817 Siloam Springs, AR 72761

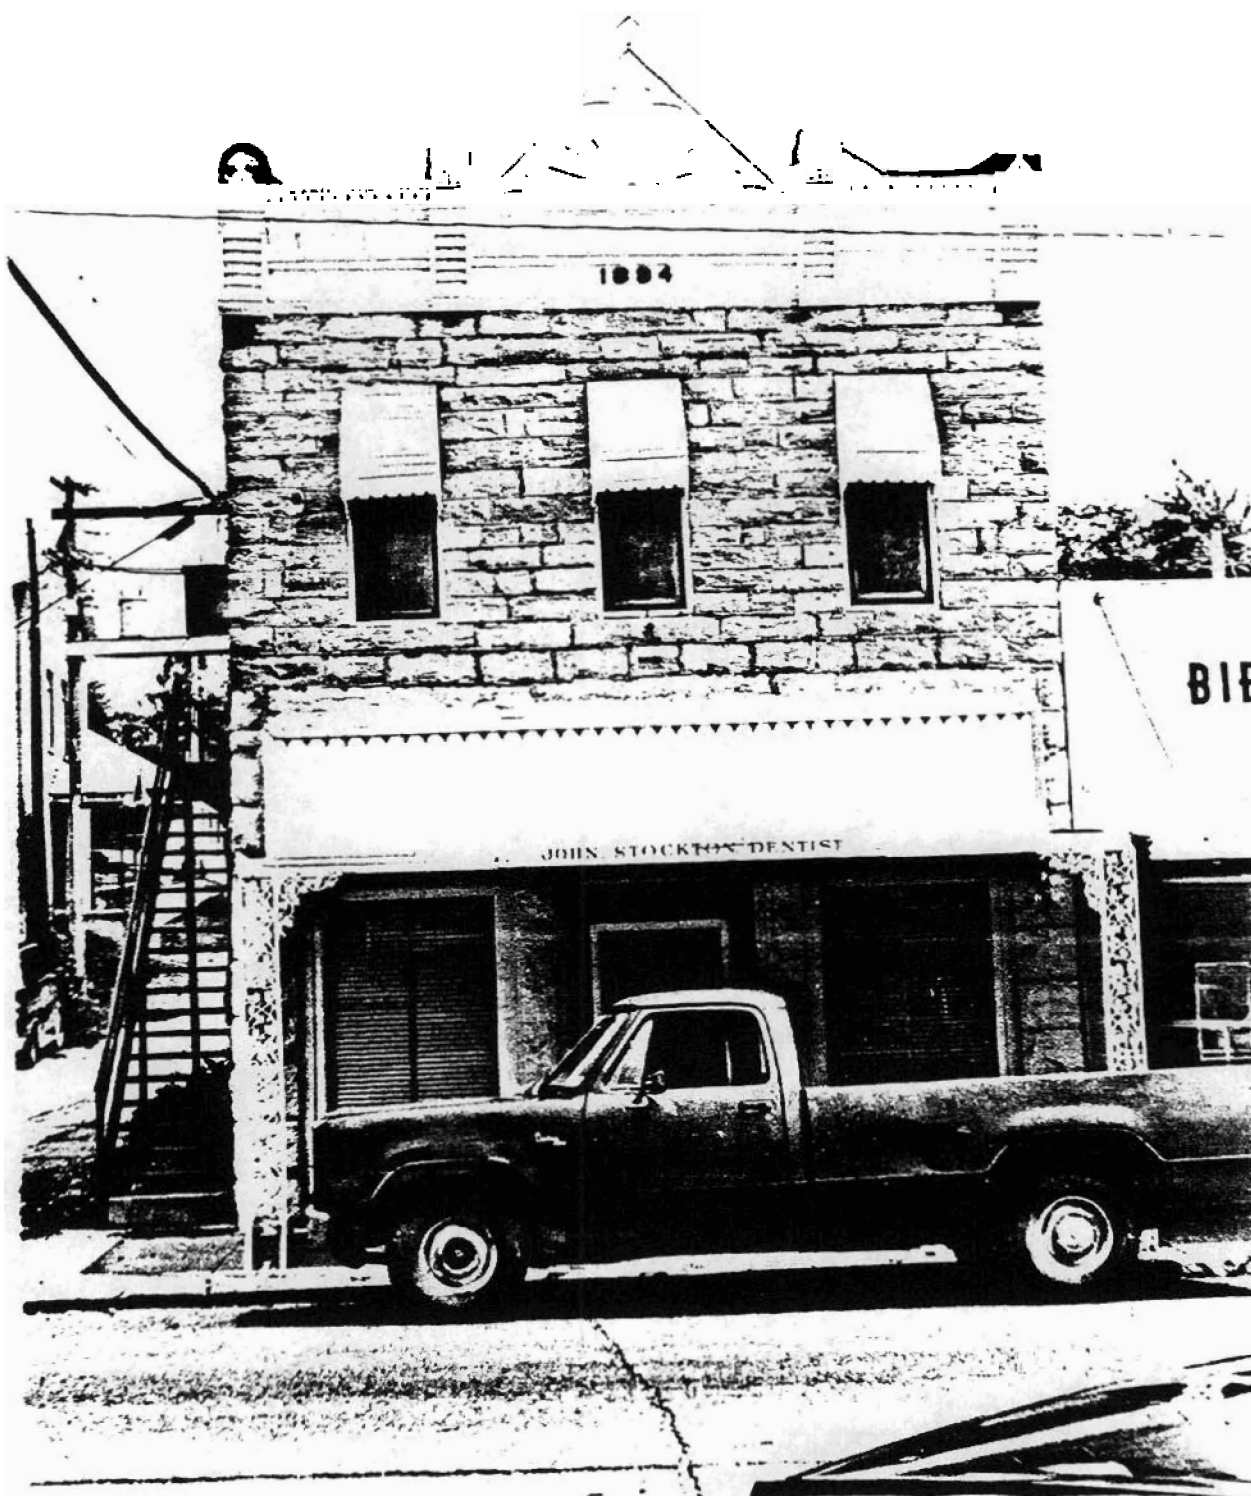
The Stockton Building, located at 113 North Broadway in Siloam Springs, is a two-story late 19th century vernacular commercial building. Constructed of load bearing stone, the building retains its ornamental pressed metal cornice. The cornice is also a parapet which is horizontal across the outer two bays and pedimented in the middle emphasizing the center bay. There are three windows on the second level covered by metal awnings. The storefront has been altered.
