NATIONAL REGISTER OF HISTORIC PLACES
REGISTRATION FORM

historic name: Henry Furniture Store Building

street & number: 107 West University

city/town: Siloam Springs

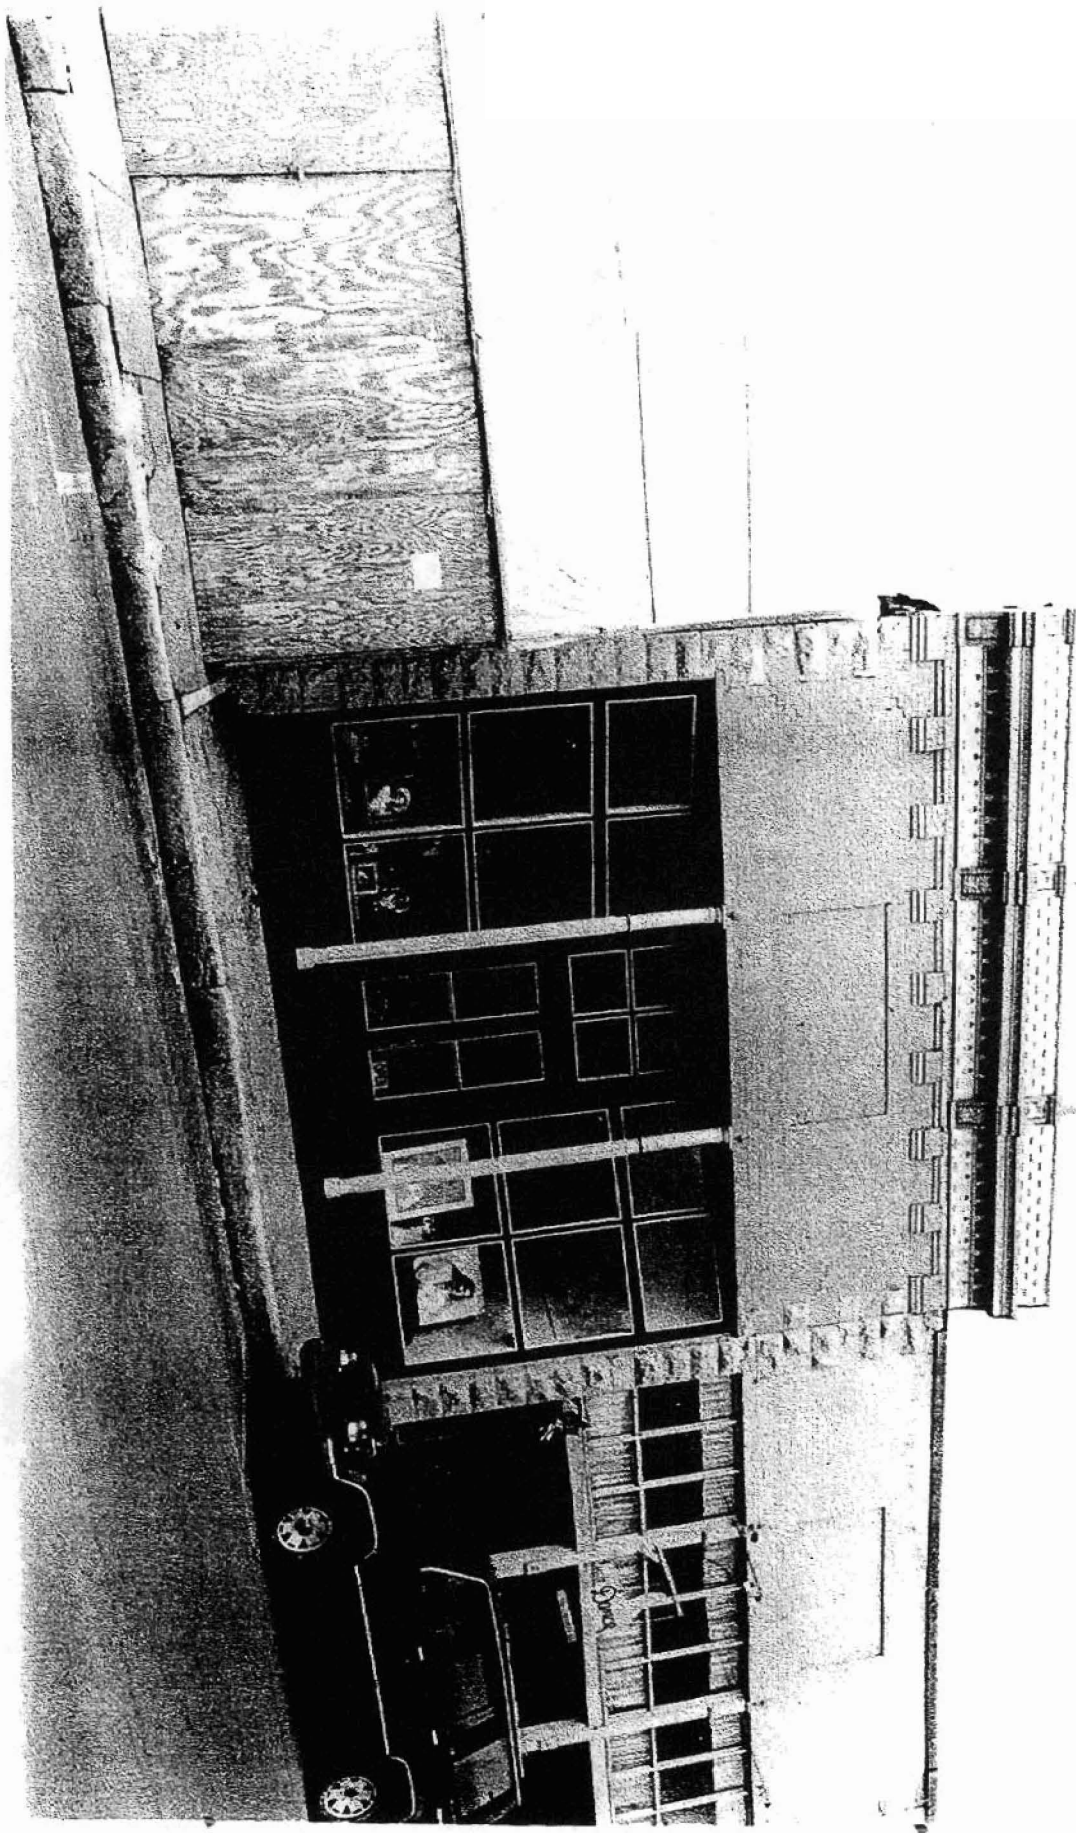
View of facade from south

The southern or front facade is composed of a large, beveled storefront on the first story and a raised brick parapet above that is ornamented with decorative brick corbeling and capped with a decorative metal cornice. The beveled storefront is constructed of wood framing and large single panes of window glass atop simple wood bulkheads. The central, double-leaf entrance is surmounted by a single four-pane fixed transom. The entrance doors are composed of two large window panes, set one above the other, and finished by a simple wood panel near the bottom that mirrors the bulkhead panels. The beveled storefront is recessed behind two thin cast iron columns that support the brick parapet above.

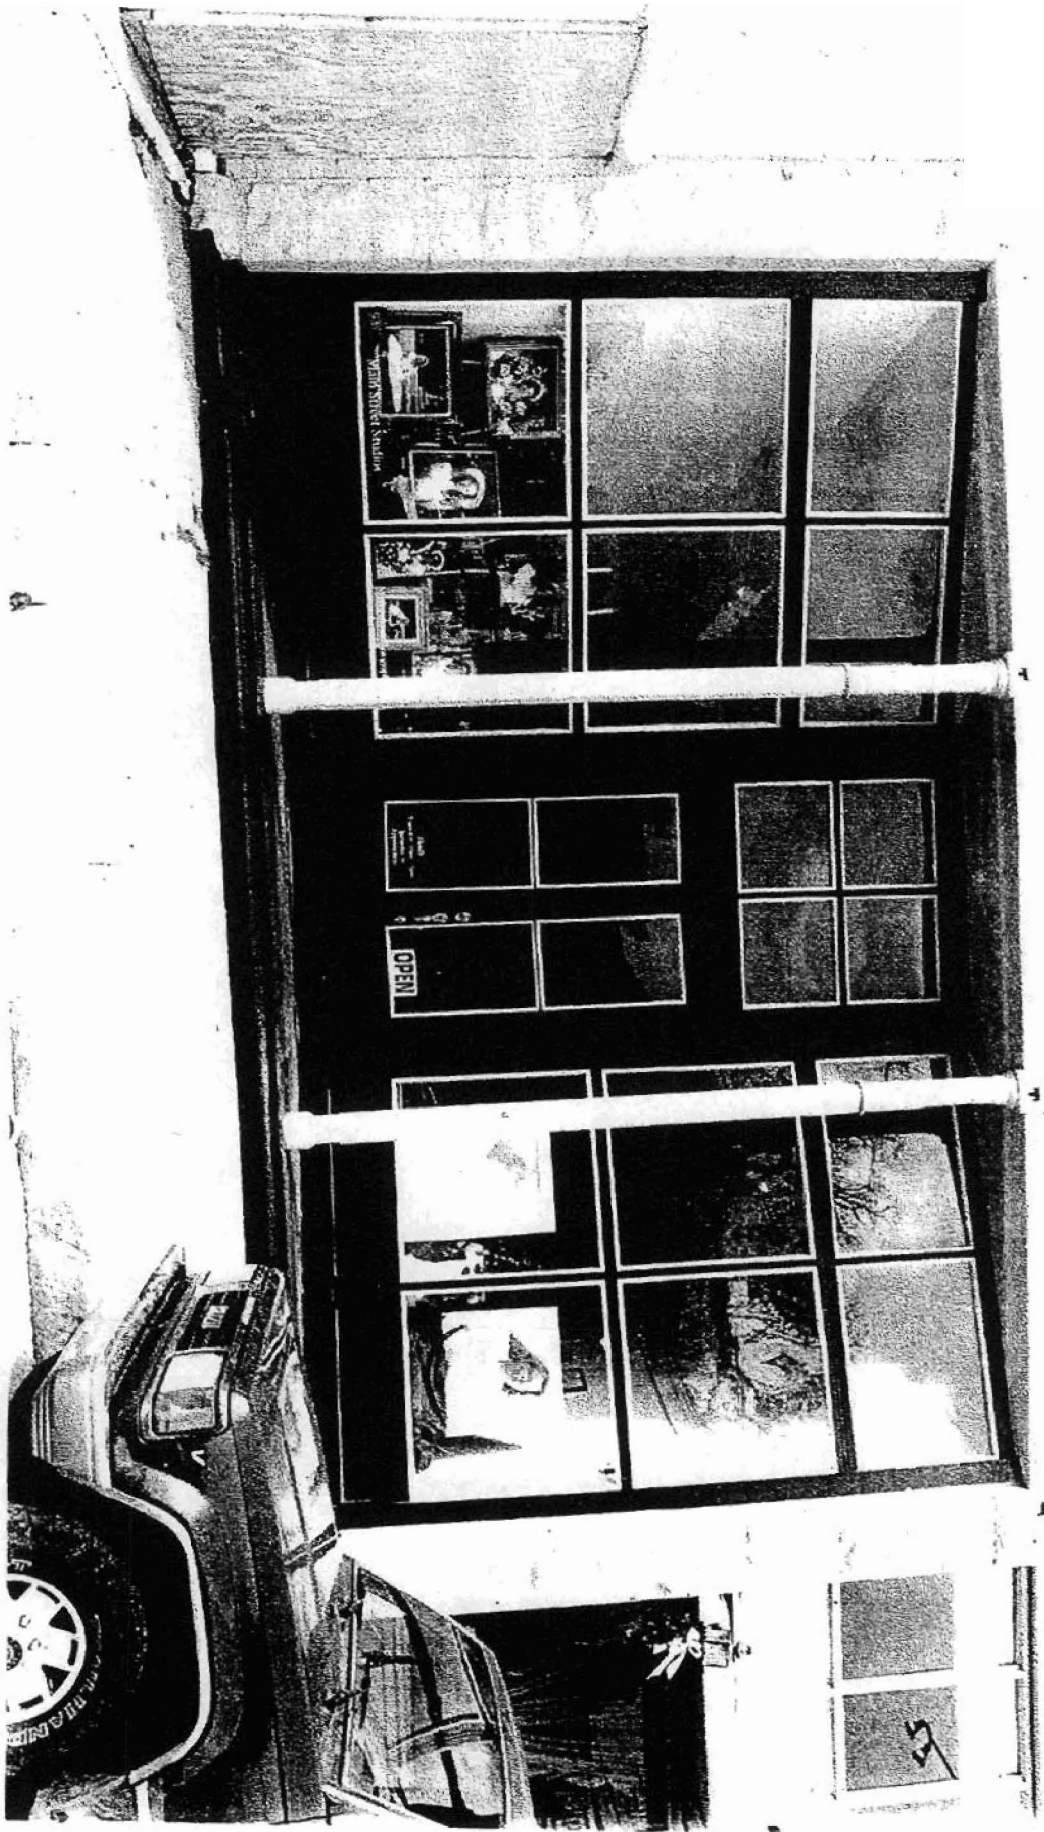
View of Storefront from South

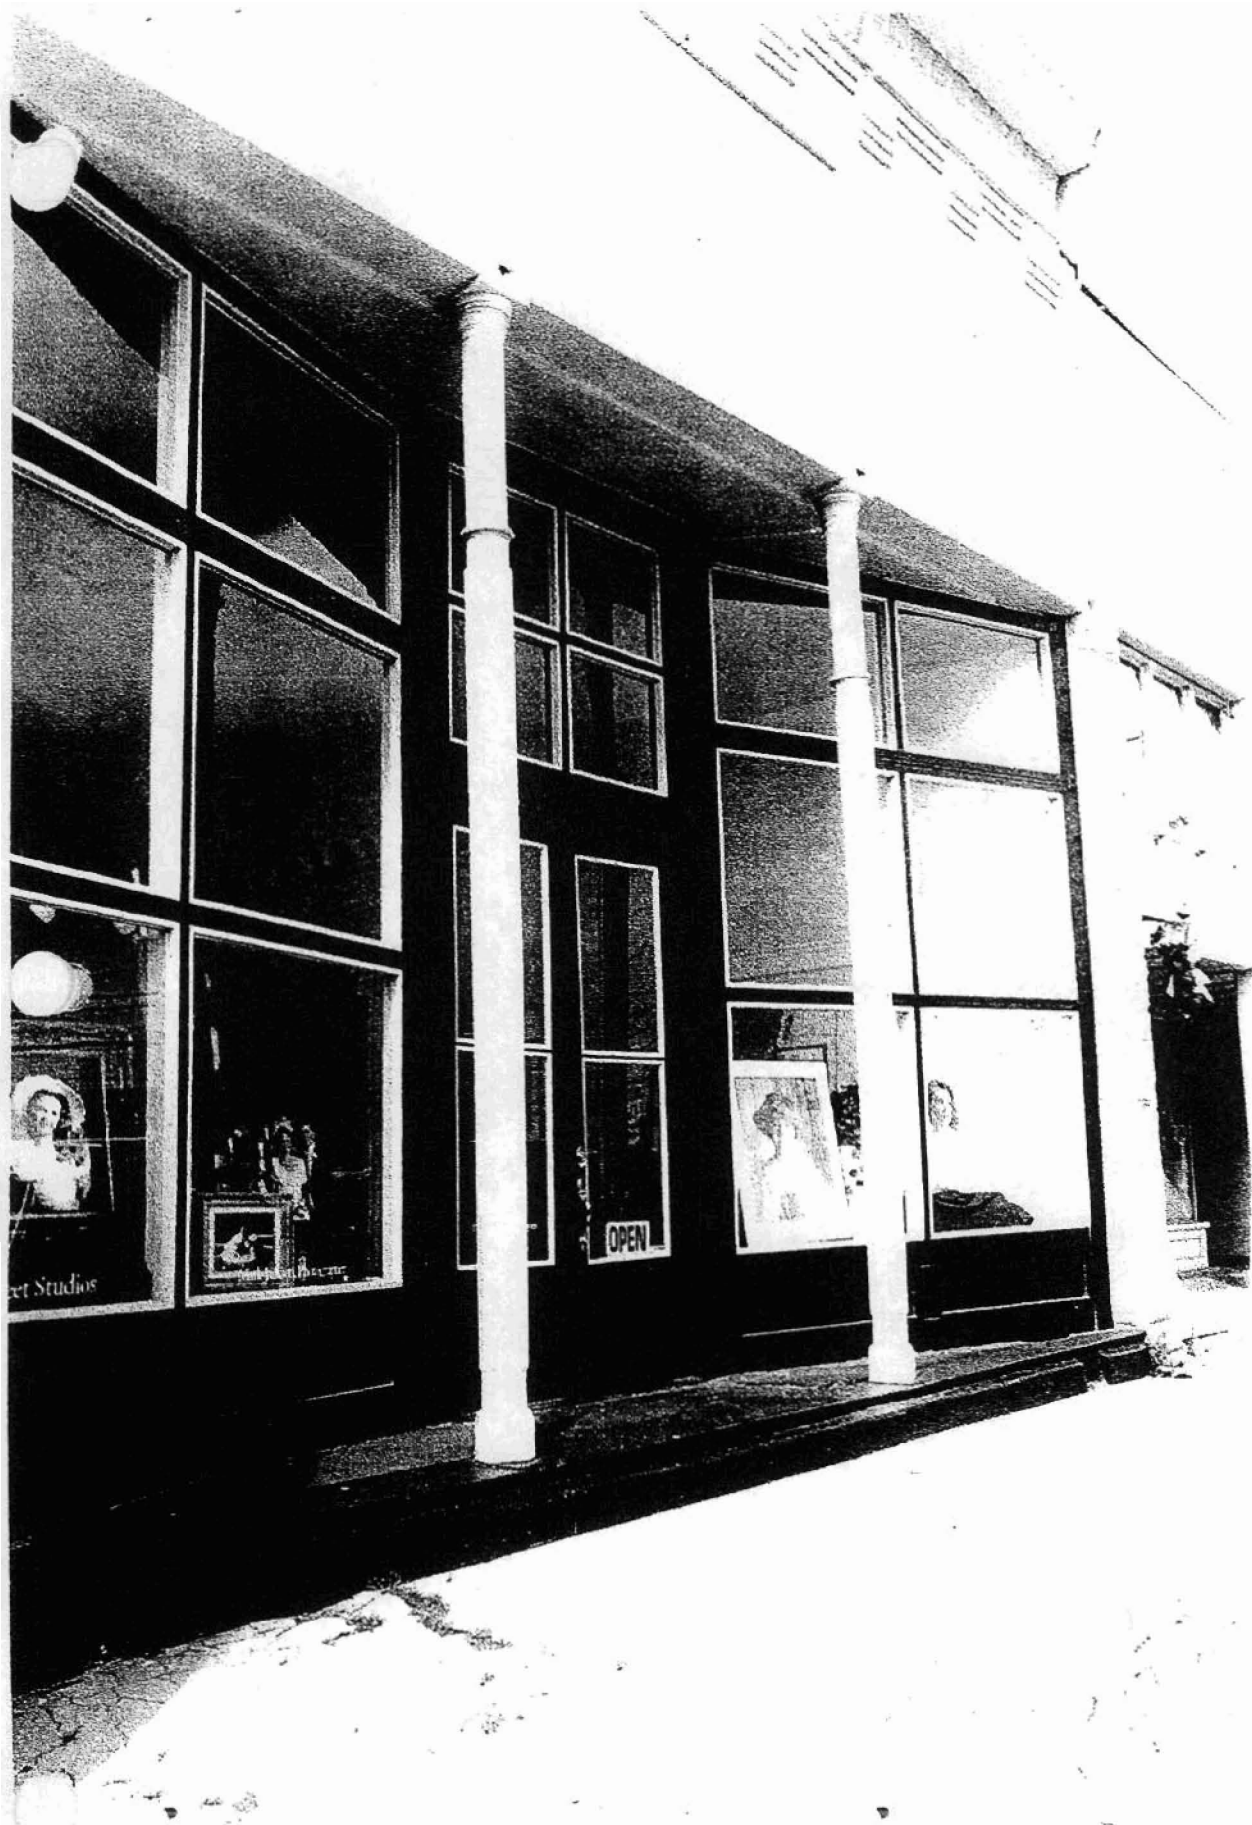
view of storefront and cast iron columns from southwest

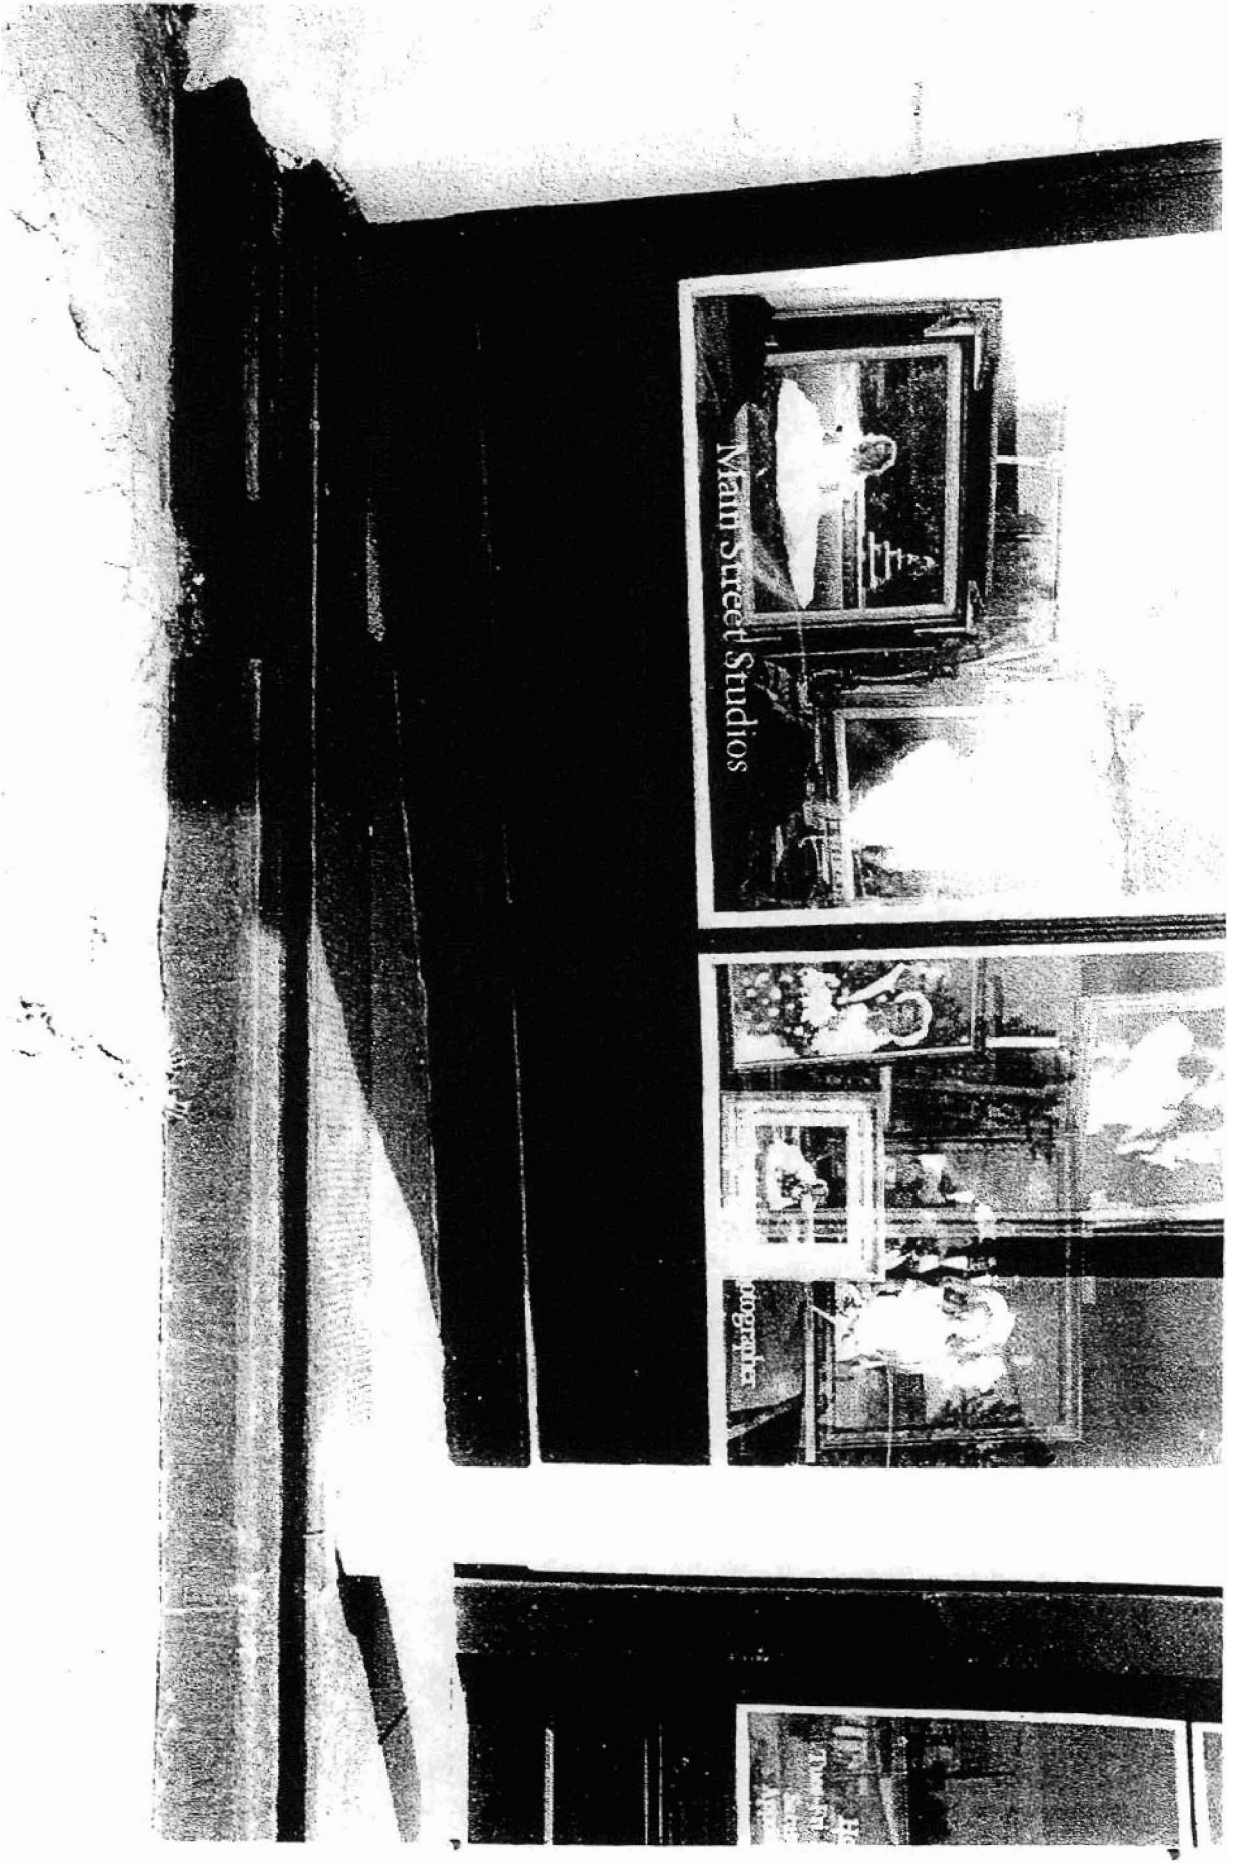
Detail of bulkheads

Materials: foundation Stone roof Asphalt
walls Brick other Wood bulkheads
Stone

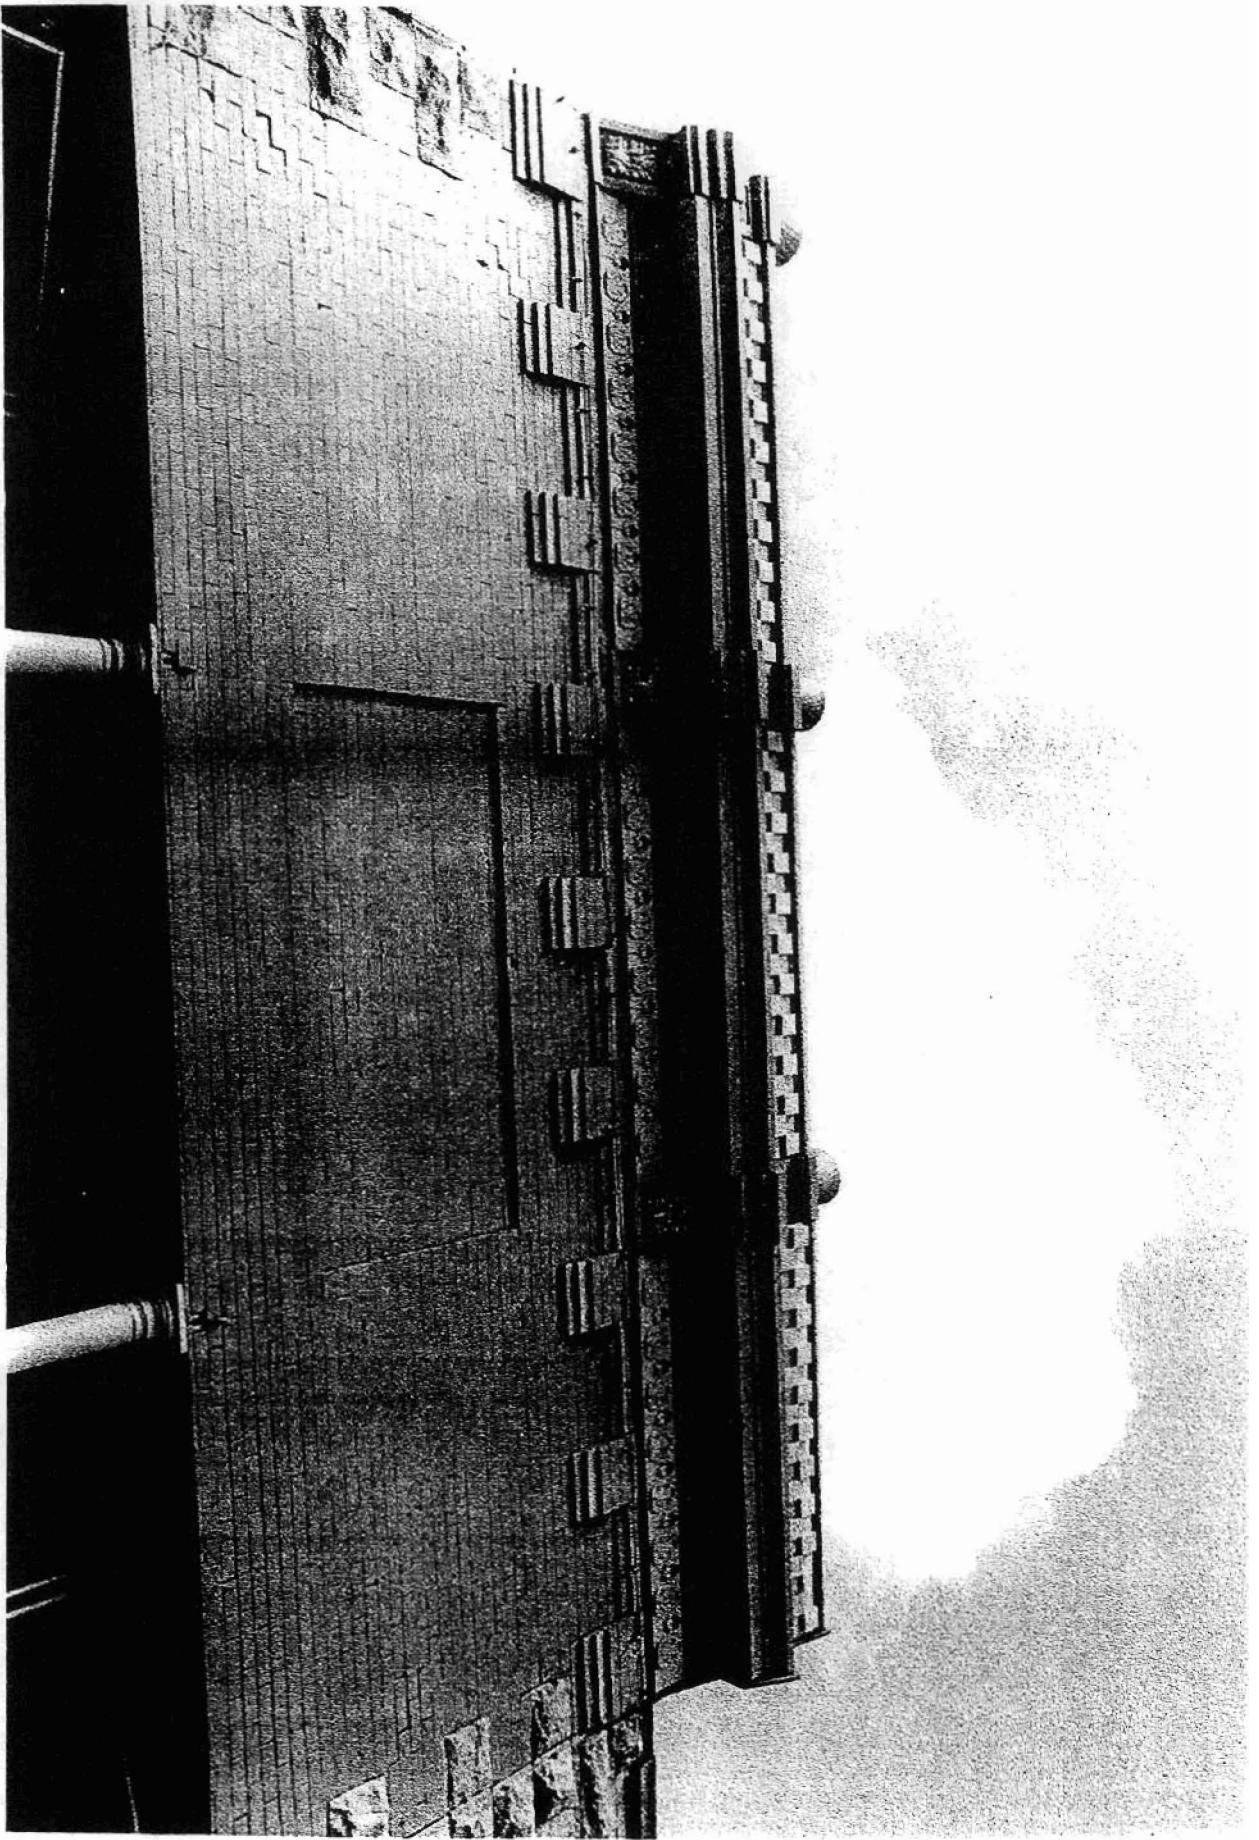
parapet and cornice

The brick parapet is composed of a tall flat wall that is ornamented only by a central, rectangular, recessed signage panel and the brick corbelling above. The projecting, decorative metal cornice, on the other hand, is quite elaborate. It is composed of three brackets that divide the frieze, entablature and dentilled parapet above. A fourth bracket, formerly located at the eastern end of the facade, was removed at some point. The frieze is decorated with a row of egg and dart details that is itself surmounted by a dentil course. The entablature projects above that and provides the depth of the cornice. The three rows of dentils above are offset in such a manner as to create a geometric star pattern. The brackets themselves are ornamented at the bottom with a single acanthus leaf and at the top with a smaller, four-pointed leaf. The masonry facade is framed with ashlar-faced stone quoins.
