1. Name of Property		
	Girl Scout Camp Historic Di	strict
other names/site number	·	
2. Location		
street & number Forest Servic	re Road #152	not for publication N/A
city, town Paron		X vicinity
state Arkansas code	AR county Perry	code AR 105 zip code 72122

SUMMARY

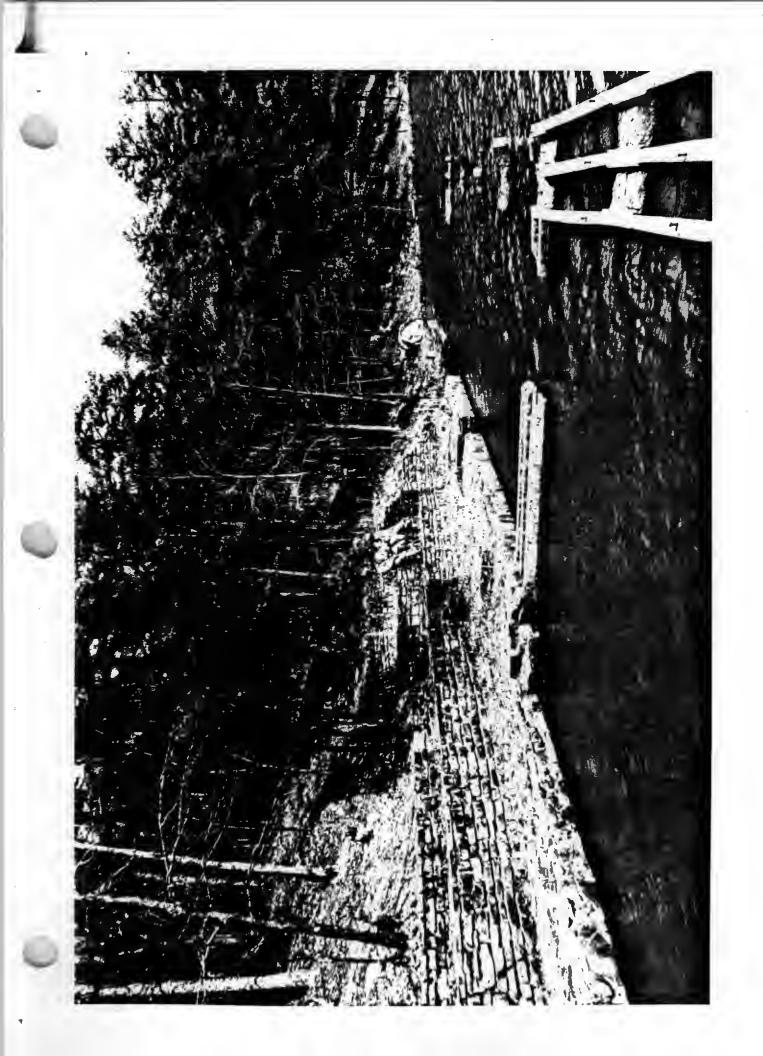
NEGATIVE ON FILE AT AHPP OVERVIEW OF Sum CRIBA BOAT HOUSE TOUN OATIONS, MARCH, 1990 PROTOGRAPHED BY A. ALBRICHT CAMP OUNCHITA GIRL Scort Camp History Distant PARON VIC. ARKENSNS 9h * 0h 5 # AND STONE RETOINING WALL

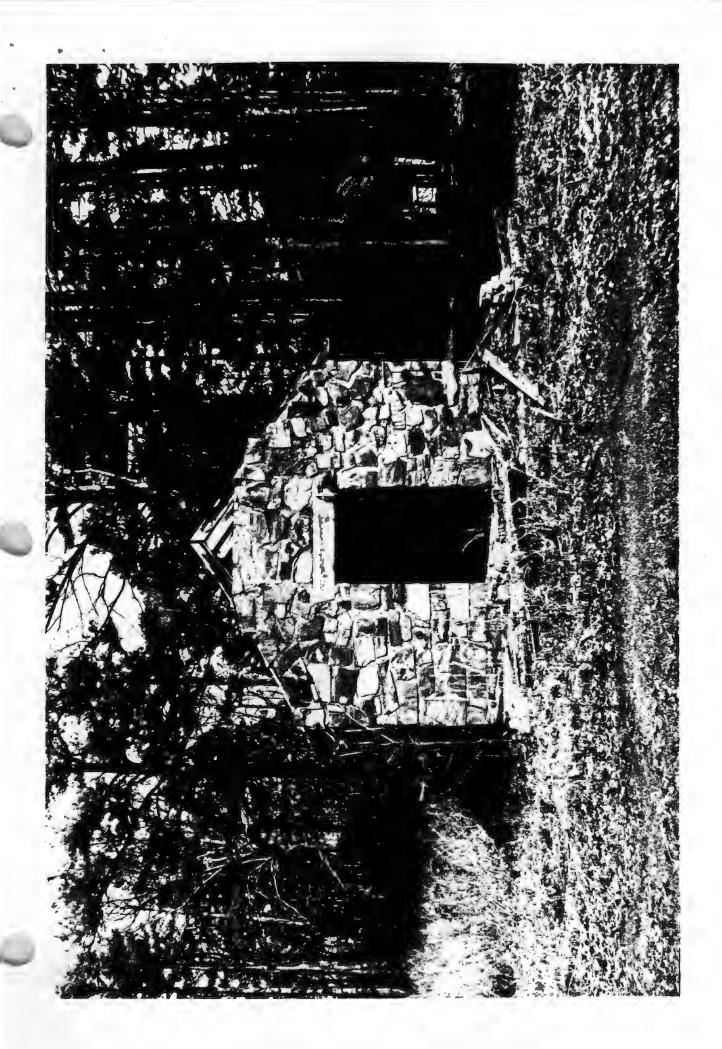
NEGATIVE ON THE AT AHPP OVERVIEW OF PAILIN WITH SHOP BUILDING IN 5# × h# PHOTOGRAPHED B& A. ALBRICHT MARCH, 1790 PARON VIC, LIRKANSAS AND OUNCHITA GIAL SCOUT CALL FUREGROUND AND STAFF BUILDING #2 IN BACKGROUND Vistorie Distinet

The Shop Building is a single story, stone masonry building. Its plan is composed of one closed pen to the south and another attached pen to the north that is open on its western elevation. The continuous fieldstone foundation and fieldstone walls are covered with the remnants of a wood frame gable roof.

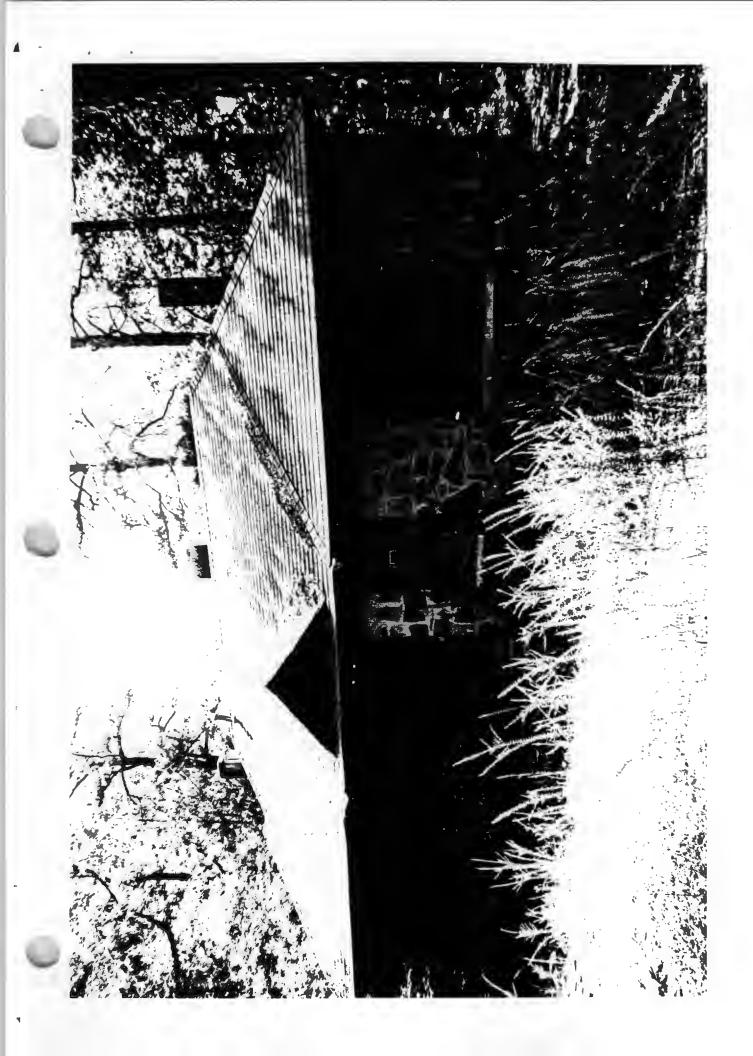
VIEW FROM WEST OF OCOLD HALL MARCH, 1990 PHOTOGRAPHED BY A. ALBRIGHT # 1 1 NEGATIVE ON FILE AT AHPP PARON VIC., ARKANSAS CAIMP DUNCHITA GIRL VOUT CAMP HISTORIE DISTRICT CARETOKER'S BUILDING

Caretaker's Building [#1]

The Caretaker's Building is a single story, stone masonry building. Its plan is rectangular. It is fenestrated throughout with six-over-six wood sash windows. Three fieldstone chimneys rise through the roof on the eastern side of the building. Its fieldstone foundation and walls are covered with a hipped roof of irregular shape.

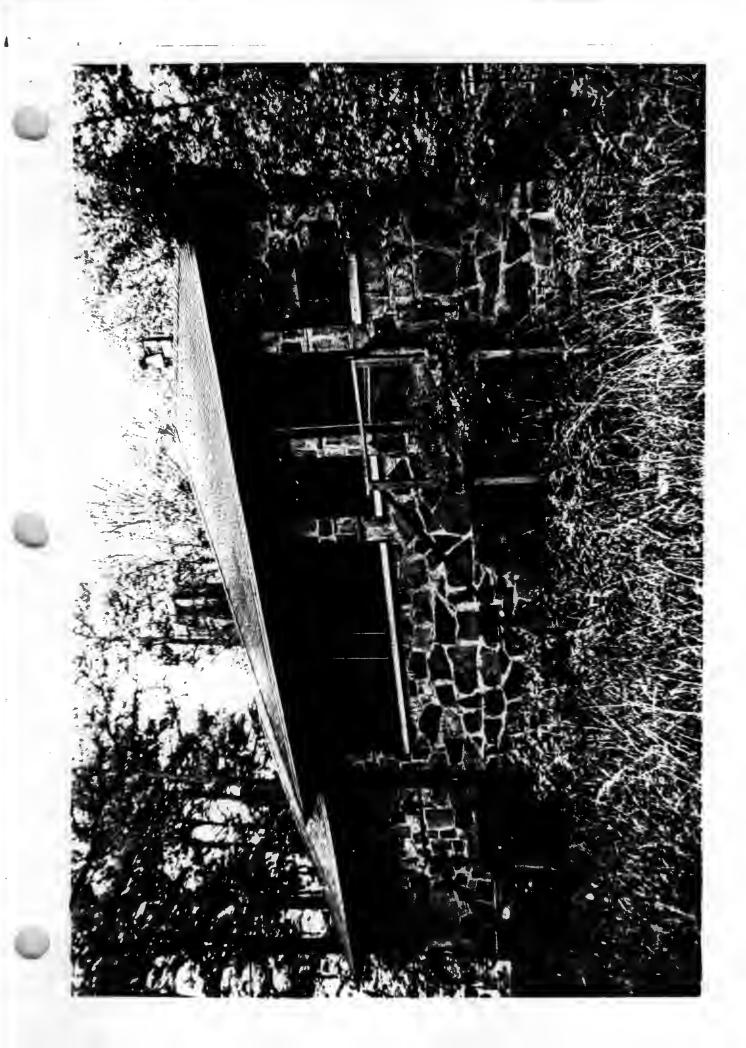
CAMP OUACHITA GIRL POUT CAMP HISTORIE DISTRICT PARON VIC., ARRANSAS PHOTOGRAPHED BY A. ALBRIGHT MARCH, 1990 NEGATIVE ON THE AT AHPP VIEW FROM EAST OF CARETAKER'S HOUSE #

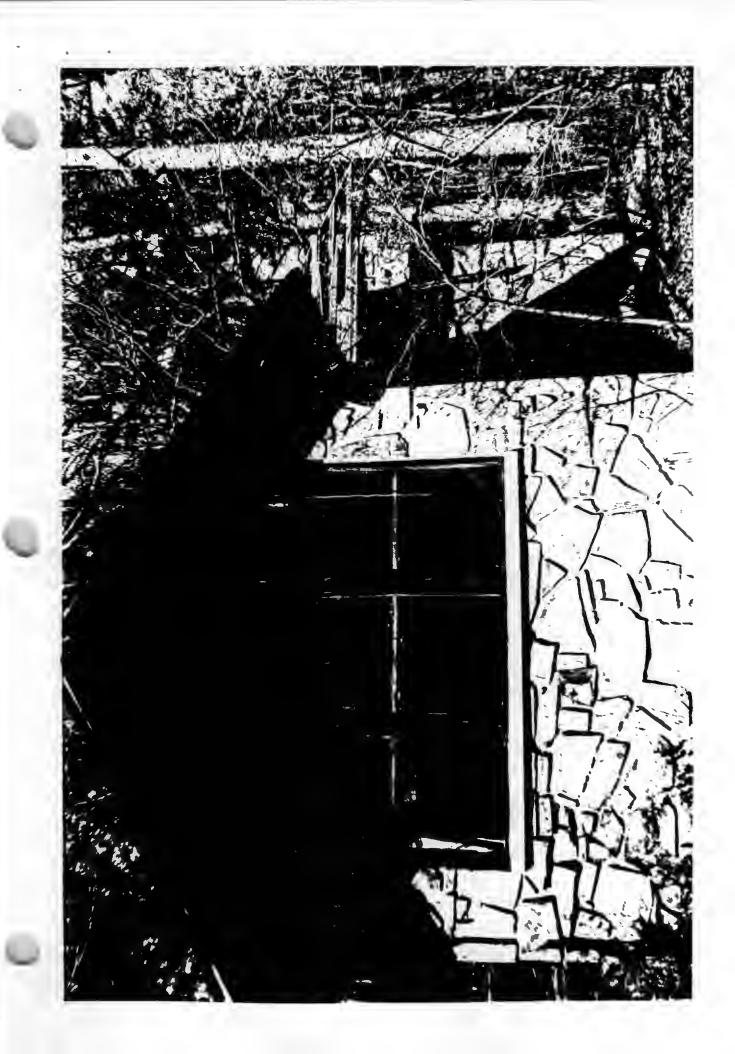
₩ W PHOTOGRAPHED BY A. ALBRICHT MARCH, 1990 VIEW OF INFIAMARY From EAST CAMP OUNCHITA CIME LOUT PAUP KISTORIC DISTRICT PARON VIR., ARKANSAS NEGATIVE ON FILE AT AMPP

Infirmary [#3]

The Infirmary is a single story, stone masonry building with a Latin cross plan and an intersecting gable roof. It is fenestrated throughout with one-over-one stationary wood windows. Its fieldstone walls are supported by a continuous fieldstone foundation.

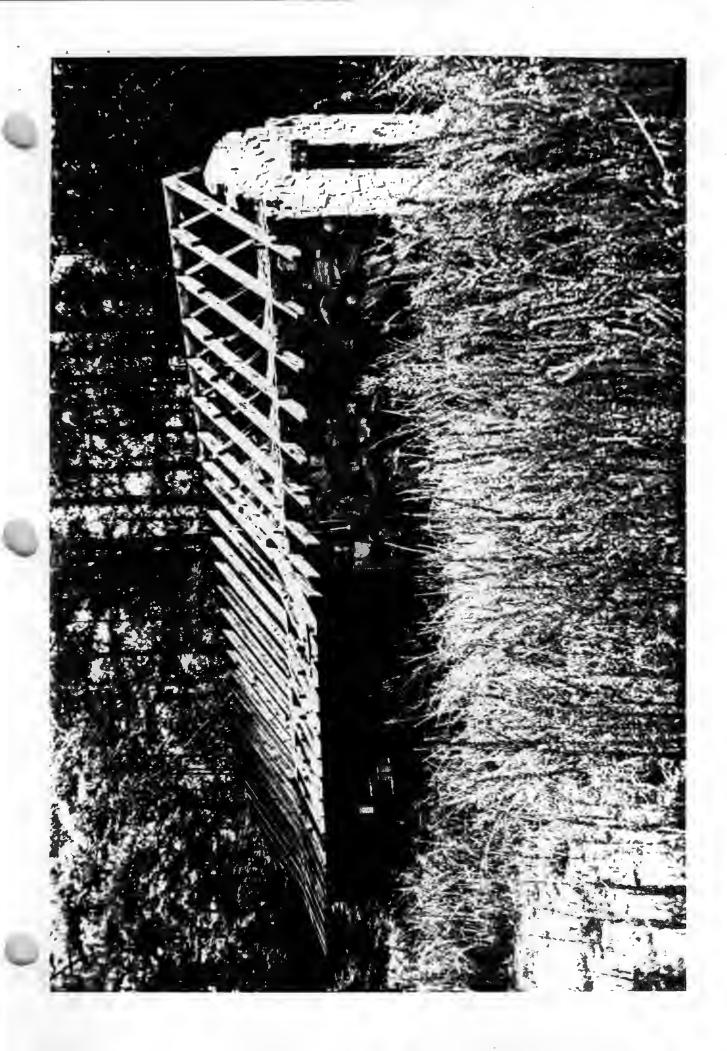
NEGATIVE ON FILE AT AHPP PHOTOGRAPHED BY A. ALSPICKT MARCH, 1990 VIEW FROM Southwest OF Ship Building CAULD OUNCHITA CLICK STORT CAUP RESTORCE PARON VIC., ARKANSAS 44 District

Shop Building [#4]

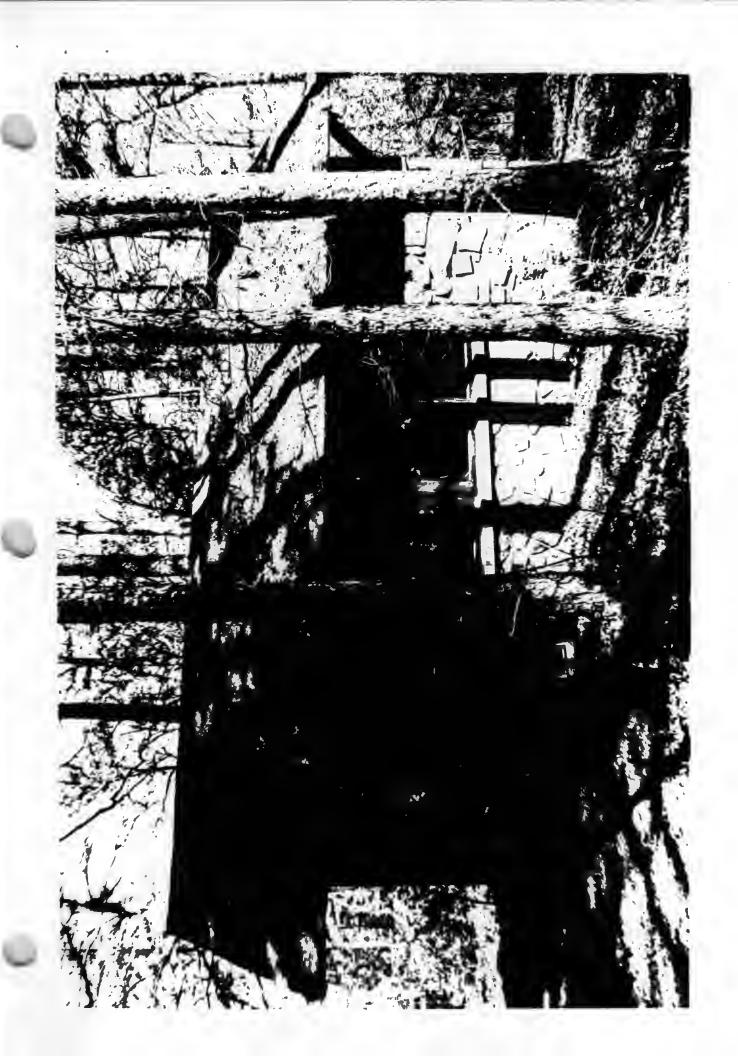
NEGATIVE ON THE AT ANPP VIEW OF STAFF SULDING #2 FROM EAST × × MARCH, 1990 CAMP OUNCHITA GIPL SPUT CAMP HISTORIC DISTRICT PHOTOGRAPHED BY A. ALBRICHT PARON VIC., ANXANSAS

Staff Buildings #1 and #2 [#7 and #8]

The two Staff Buildings are both quite similar, each being a single story, stone masonry building with a wood frame and log gable roof that projects over the front facade and is

supported on large, log posts. Log trusses are used beneath the gable roof on the porch, and the front elevation below is relieved only by a central entrance. Both are lighted by oneover-one stationary wood windows. Their continuous fieldstone foundations and fieldstone walls are covered with a composition shingle roof.

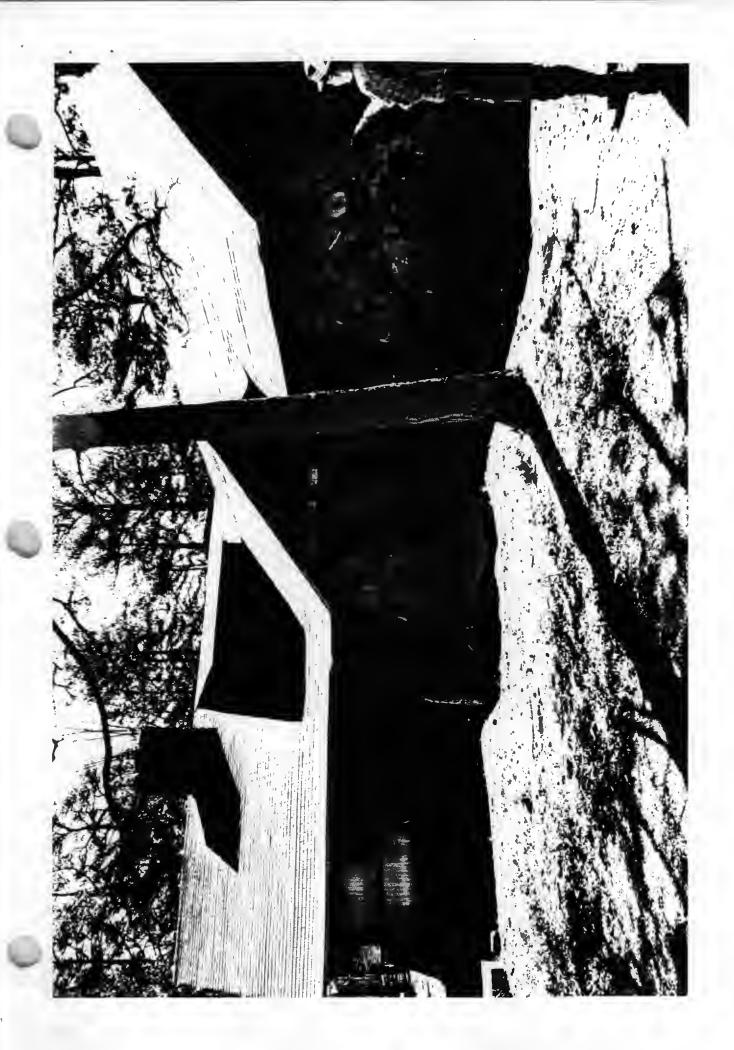
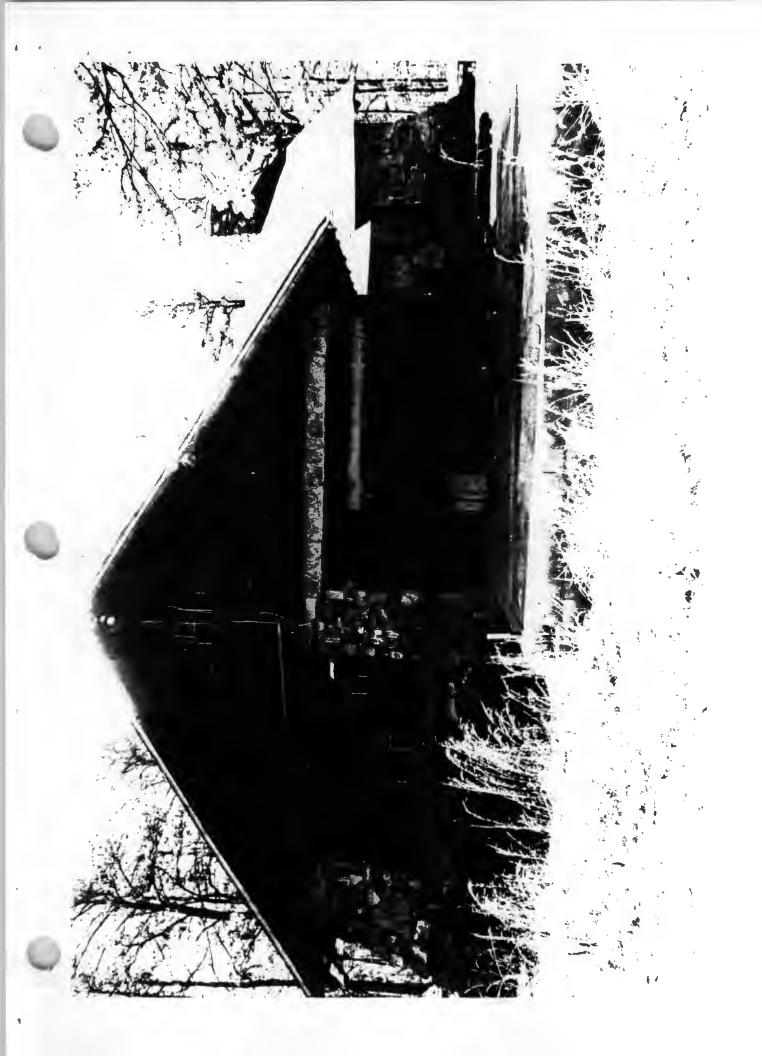
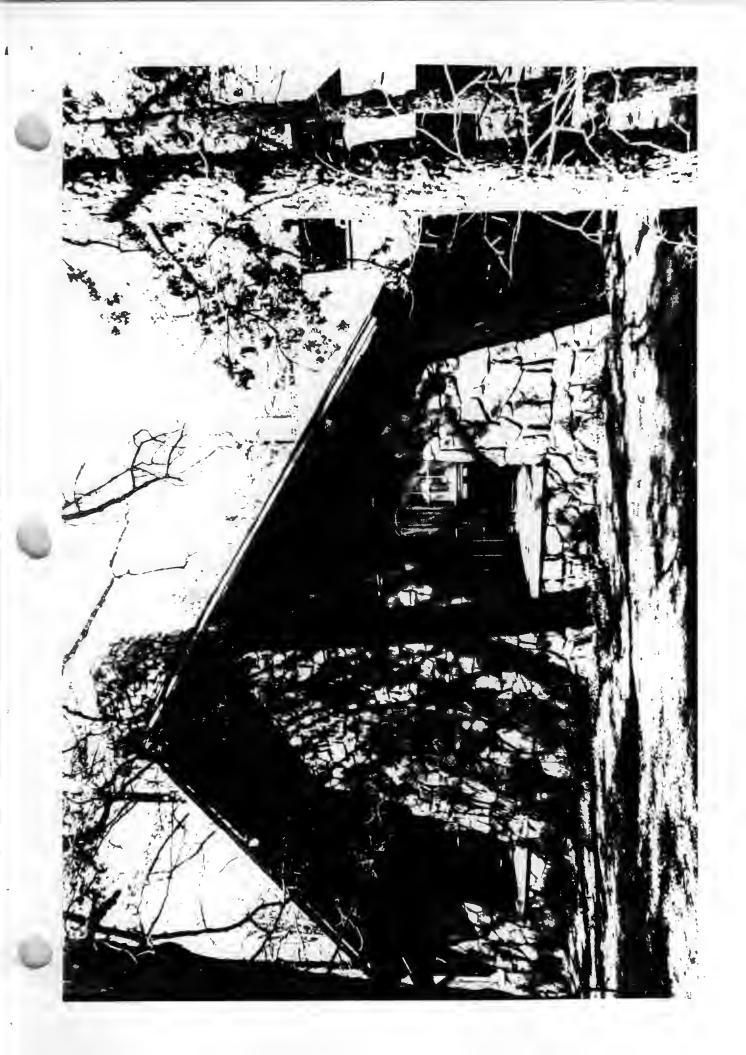
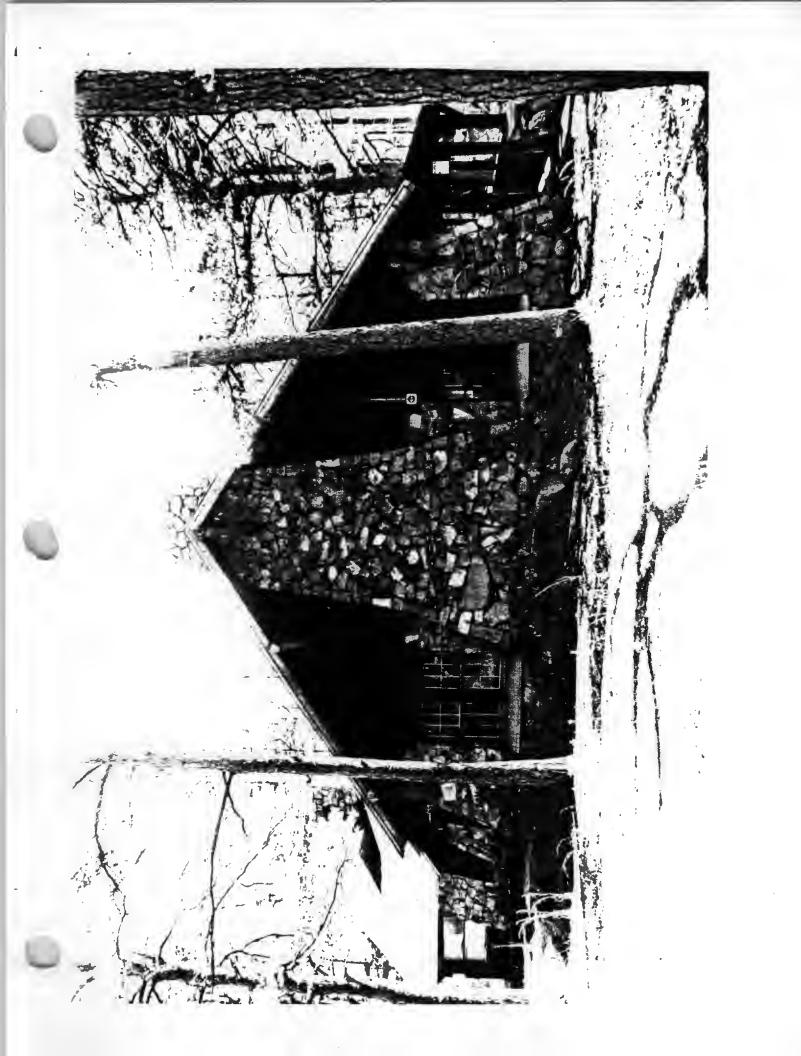
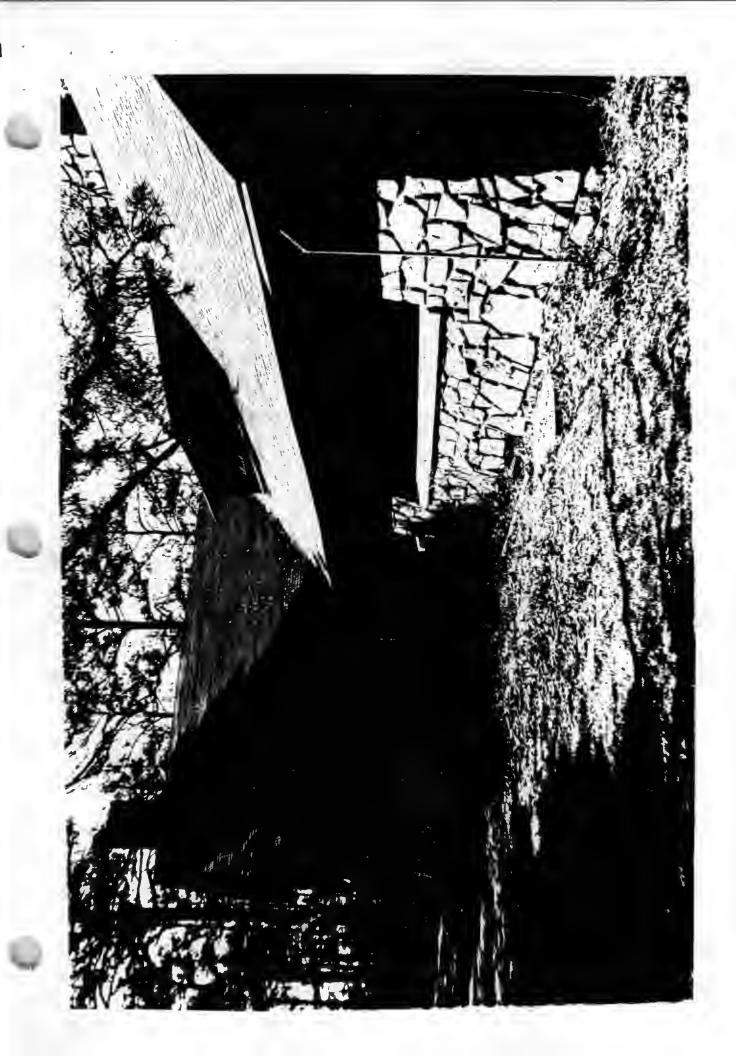
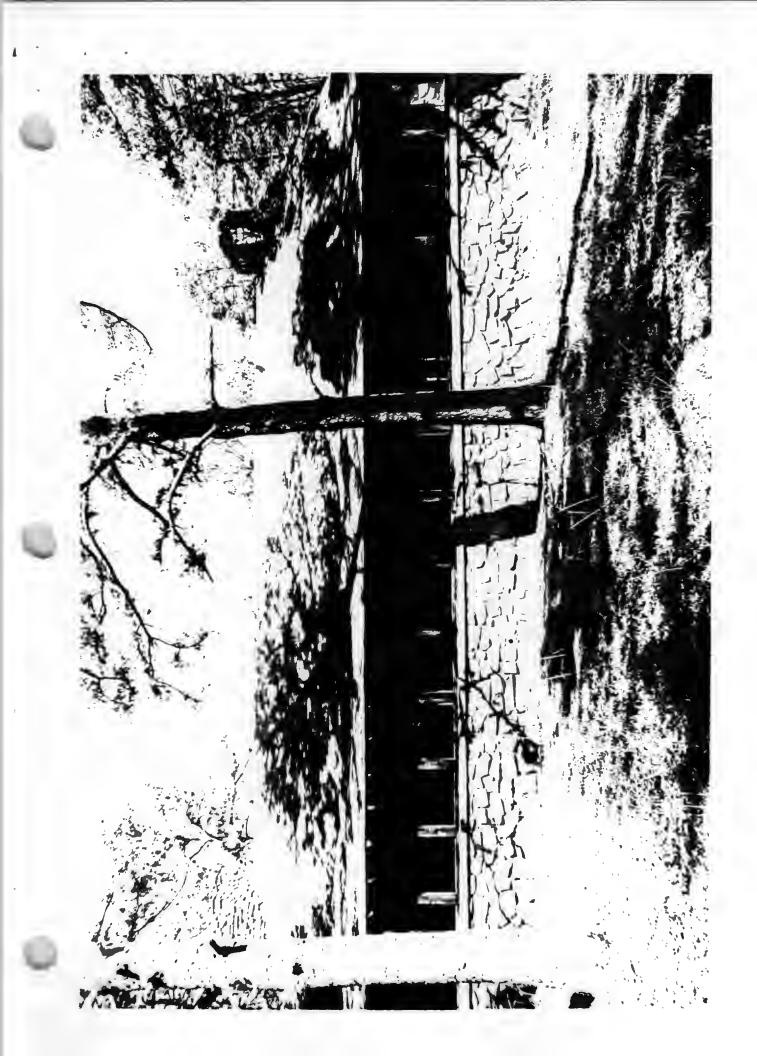
VIEW FROM NORTHWEST OF OGDEN HALL NEGATIVE ON FILE AT AHPP PHOTOGRAPHED BY A. ALBRIGHT 146 MARCH, 1990 CAMP OUSCHITA GIPL Scout CAMP VISTORIE DISTRICT PARON LIC., ARKANSAS

CAMP OVACHITA GIRL SCOUT CAMP HISTORIC DISTRICT PHOTOGRAPHED BY A. SIBRIGHT NEGATIVE ON FILE AT AHPP VIEW FROM NORTH OF OGDEN HALL PARON VIE., ARKANSAS が MARCH, 1990

PHOTOGRAPHED BY A. LIBRIGHT MARCH, 1890 NEGATIVE ON FILE AT AHIPP VIEW FROM EAST OF OGDEN HALL 3# PARON VIC., ARKANSAS JANID OUACHITA GIRL OCOUT CAMP KISTORIC DISTRICT

PHOTOGRAPHED BY A. ALBRIGHT MARCH, 1990 VIEW FROM WEST OF OGOEN HAAL NECOTIVE ON FILE AT AHIPP CAMP OUNCHISA GIRL SCUT CANIP HISTORIE DISTINCT 94 PARON UR, ARKANSOS

VIEW OF OGDEN HALL (#6) FROM NORTHEAST CAMP OUAPHITA CIRL SPOLT PAUR RISTORIC DISTRICT NEURTINE ON FILE AT AHPP PHOTOGRAPHED BY A. ALBRIGHT Paron vir., ARKANSAS MARCH, 1990

NEGATIVE ON THE AT AHPP VIEN FROM JOUTH OF OGDEN HALL PARON VIE., ARKANSAS DHOTOGRAPHED BY A. ALBRIGHT MARCH, 1990 CAMP DUNCHITA GIRL SCOUT CAMP HISTORIC DISTRICT 0 ¥

Ogden Hall (a.k.a. Great Hall) [#6]

Ogden Hall is a two-story, stone masonry and wood mess hall and function building. It spreading stone masonry walls rise from the ground and are accented by the twin stone chimneys at either end of the auditorium itself. The plan is irregular, as the kitchen and other office space extends from the north side of the auditorium and an open, screened porch runs almost the full length of the auditorium's southern elevation. Its intersecting gable roof is covered with asphalt shingles and ornamented with decorative round, log brackets and exposed log purlins at the gable ends.

It was designed by Thompson, Sanders & Ginnochio, architects, of Little Rock and is the only building in the district known to have been designed by an architect.

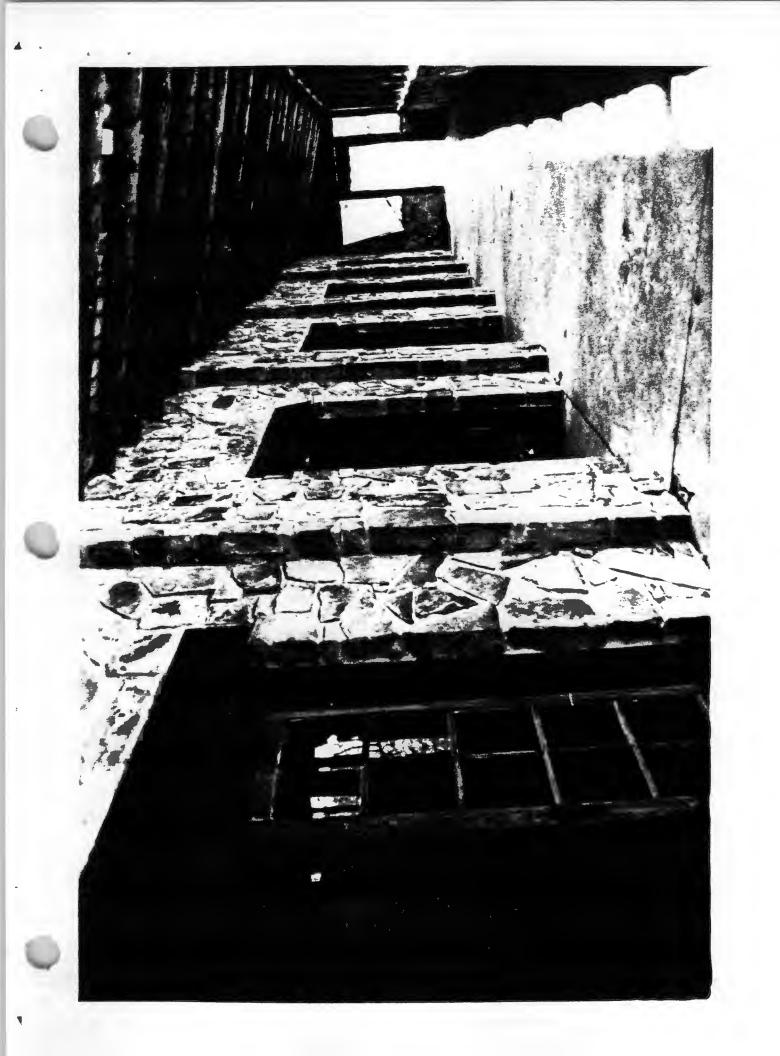
UIEW OF INTERIOR SCREENED PORCH OF OGDEN HALL NEGATIVE ON FILE AT AHPP PHOTOGRAPHED BY A. ALBRICHT PARON VIC., ARKANSAS #6 MARCH, 1990 MANIE OURCHITA GIEL VOUR CAMP VISTORIE DISTRICT

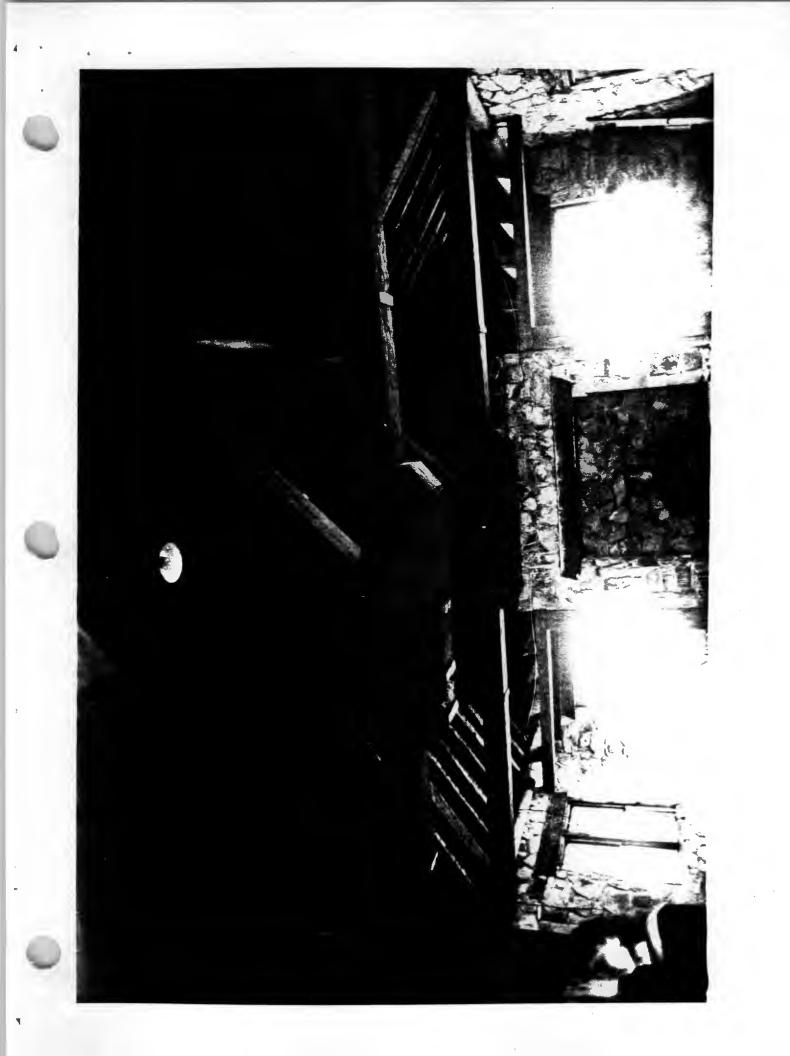
PHOTOGRAPHED BY A. AL BRIGHT MARCH, 1990 NEGATIVE ON FILE AT AHPP VIEW DE ROOF TRUSSES DE OGDEN HALL CARON VIC., APRANUSAS CAMIP OUNCHITA GIAL Scour CAMIP theremic 9# DISTINCT

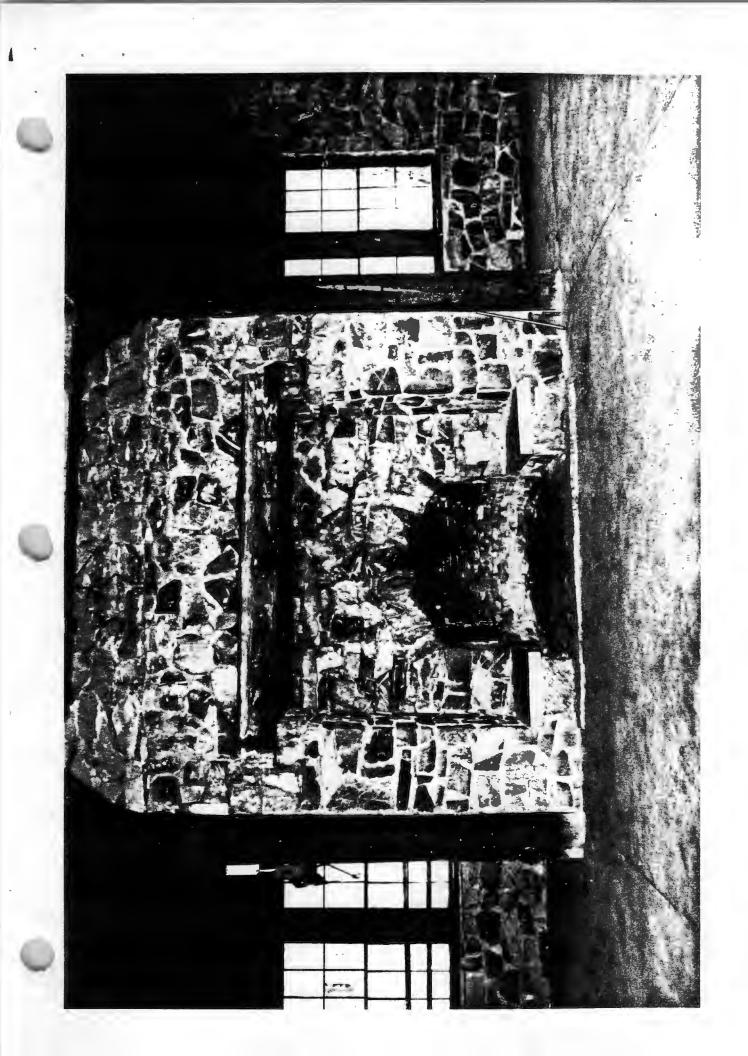
NECATIVE ON FILE AT AHPP #6 CAMP DUACHITA GIRL Scout CAMP HISTORIC DISTRICT MARCH, 1990 PARON VIC., ARKANSAS PHOTOGRAPHED BY A. ALBRIGHT INTERIOR VIEW OF OGDEN HALL SHOWING FIREPLACE

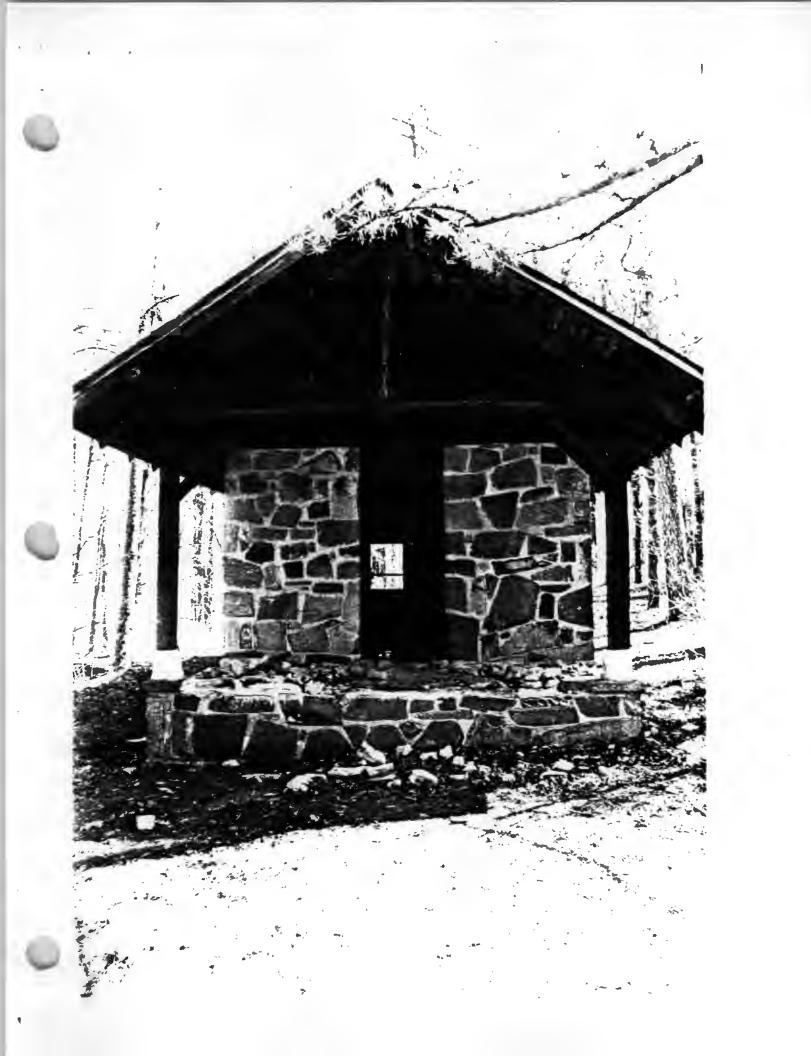
NEGATIVE ON THE AT AHPP たま 111ARCH, 1990 L'IEW FROM WEST OF STAFF BUILDING PHUNCKINED SY A ALBRICH-2, xON U.C. ANKANSAS A MID OUROWITH CIPE SCOLT CAMP HISTORIC DISTRICT #

PARON VIC, ARRANSAS PIDTOGRAPHED BY A. ALBRIGHT MEGRINE ON THE AT ANPP VIEW OF STAFF BLOG. #1 FROM NORTH CAMP DURCHITA GIRL SPOUT CAMP HISTORIC DISTRICT ちま

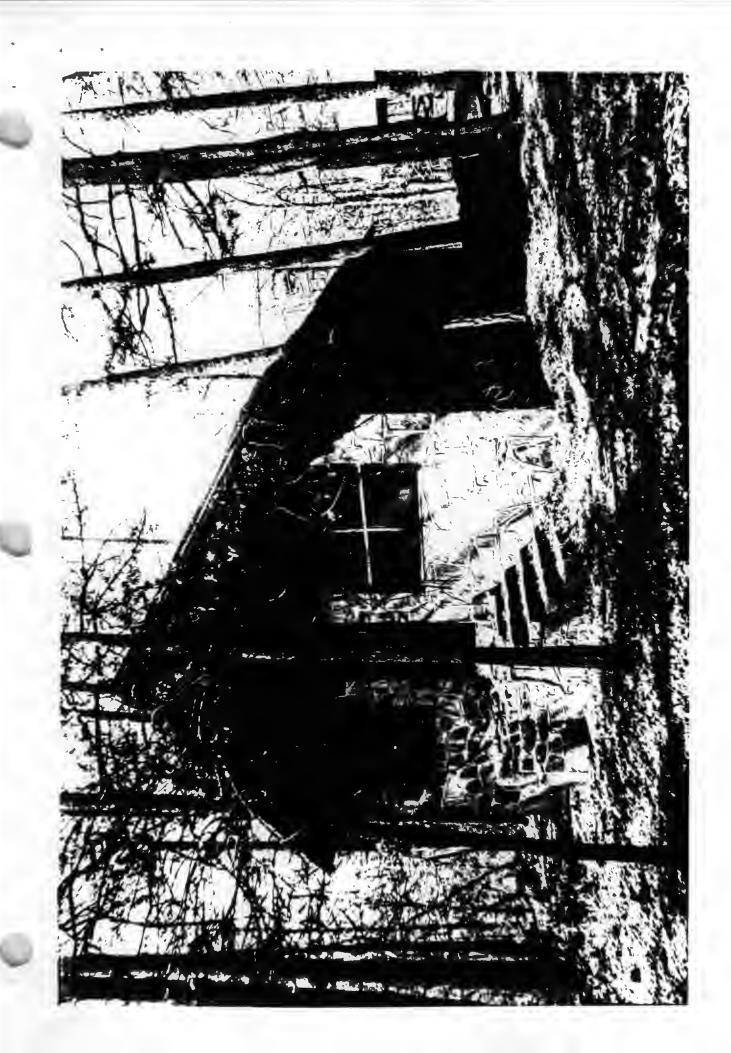
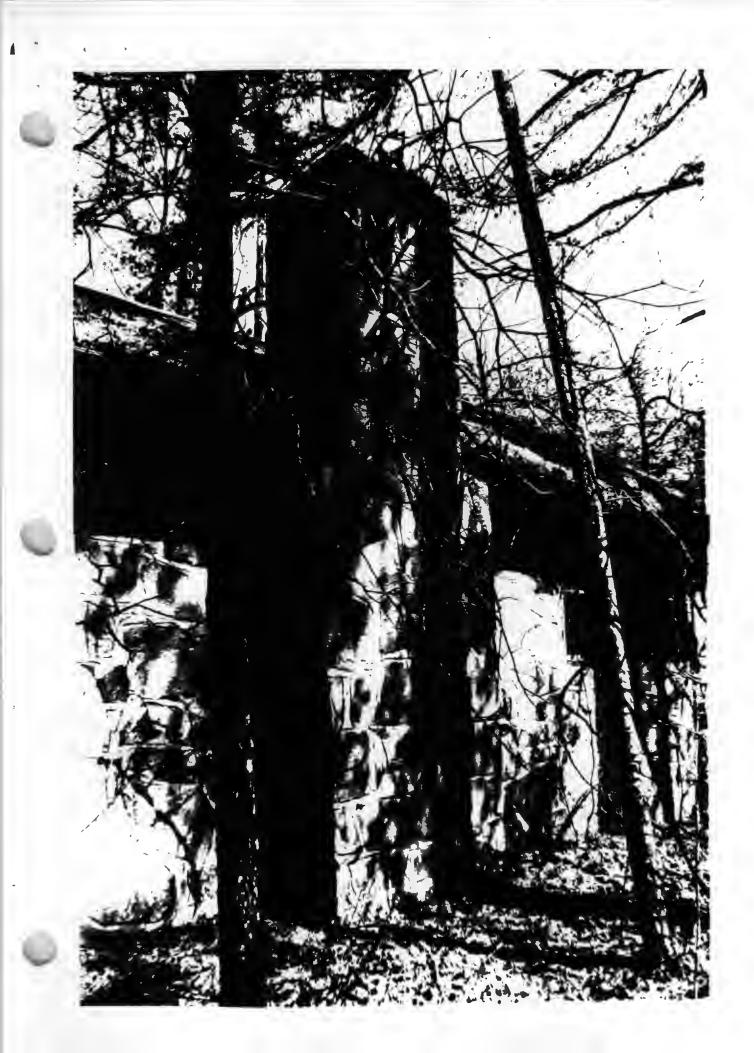
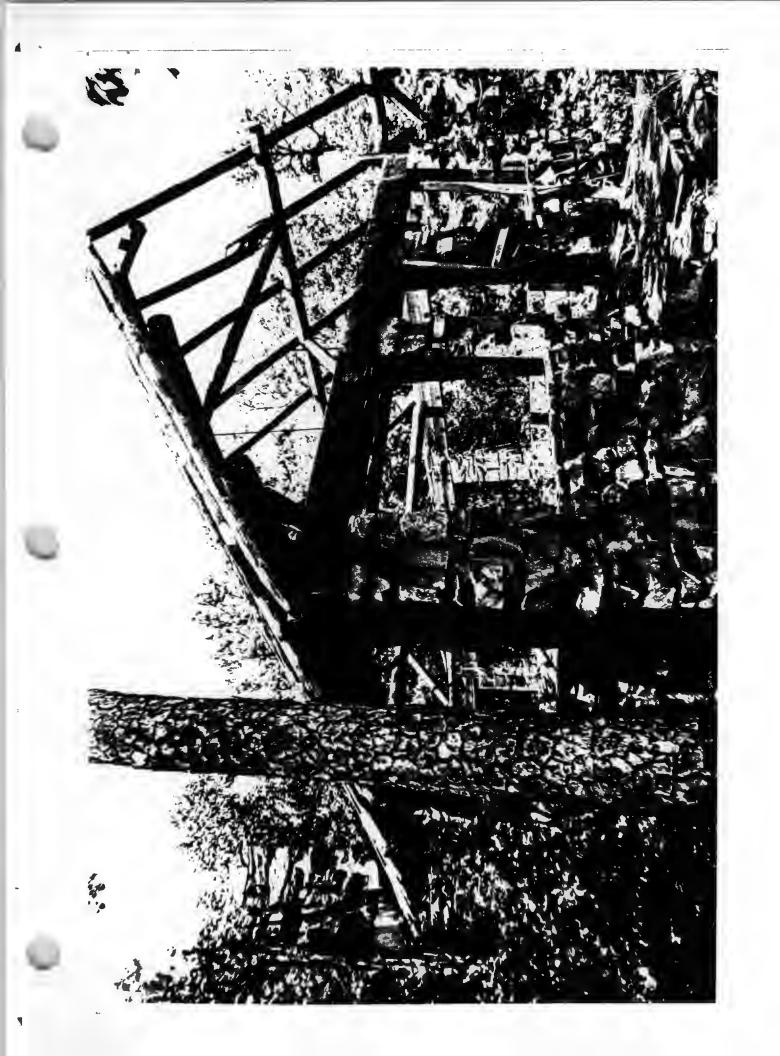
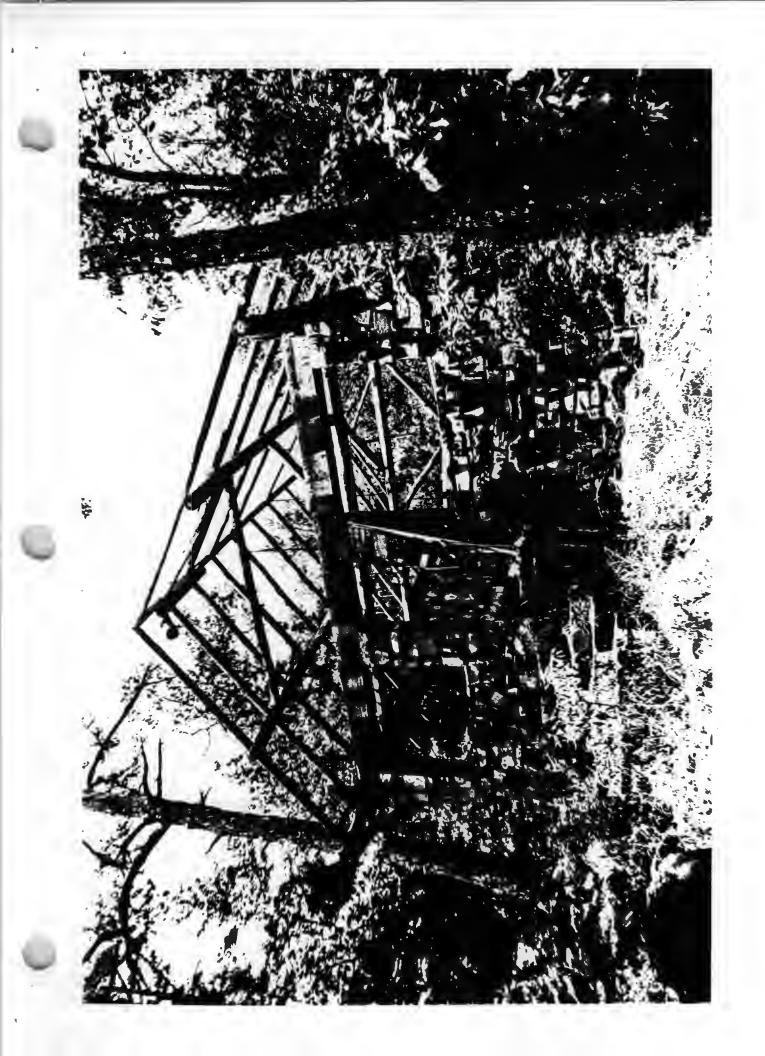
NEGATIVE ON THE AT AHPP VIEW OF UNITHOUSE FROM NORTHEAST CAMP OLAPHITA GIRL STOLT CAMP HISTORIC DISTRICT MARCH, 1990 PHOTOGRAPHED BY A. ALBRIGHT PARON VIC., ARKANSAS 424

PARON VIC, ARKANSAS CAMIP OUDENITA CIRL SIGUT CAMIP VISTORIE DISTRICT PHOTOGRAPHED BY A. ALBRICHT NEGATIVE ON FILE AT AHPP #37 UNIT THUSE CHIMNEY DETAIL MARCH, 1990

CAIND OUDENITA CIEL Scort CAMP RISTORIE DISTRICT PHOTOGRAPHED BY A. ALBRIGHT MARCH, 1990 PARON VIE. ARKANSAS VIEW FROM NURTHWEST OF UNITHOUSE NEGATIVE ON THE AT AHPO 11#

CAMP OUNCHITA CIRL Scout PAUL HISTORIC DISTRICT 11# PARON VIE, ARKANSAS VIEW FROM BUTHWEST OF UNITHOUSE PHOTOGRAPHED &Y A. ALBRIGHT NEGATIVE ON FILE AT AHPP MARCH, 1990

The four Unithouses [#11, #26, #27 and #37] served each of the four campsite clusters and were used for campsite meeting, functions, and other group activities within the campsite. All four are identical: each is rectangular in plan and entered through a central single-leaf door in three of its elevations with an exterior chimney placed in the center of one of the long sides. Each entry is flanked with a large window to either side. They are of stone masonry construction and covered with a composition shingle gable roof the gable ends of which are filled with board-and-batten.

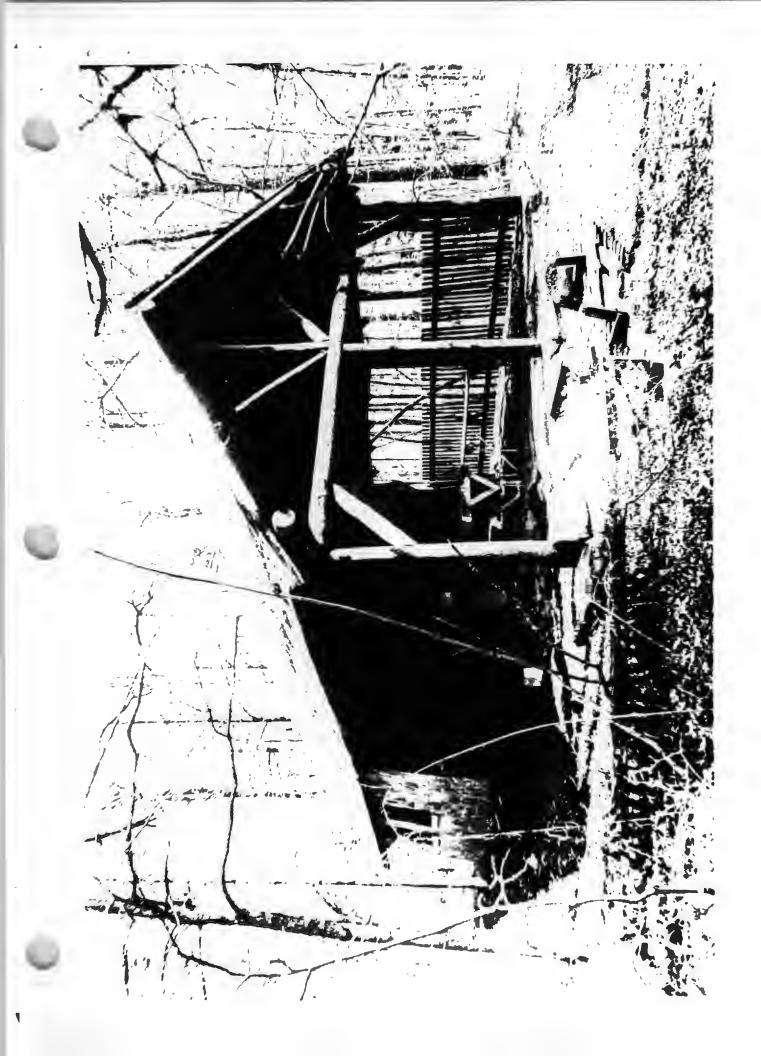
CAMP DUNEWITH CIRL SCOUT CAMP KISTORIC DISTRICT NEGATIVE ON THE AT AHPP VIEW OF BATHHOUSE FROM JOUTHWEST MARCH, 1990 PARON VIE, ARKANSAS PHOTOGRAPHED BY A. ALBRIGHT # 34

CAMP OUNCHITA CIRL STOUT CAMP HISTORIC DISTRICT # 34 NEGATIVE ON FILE AT AHPP VIEW OF BATHMOUSE FROM NORTHEAST PARON VIC., ARKANSAS PHOTOGRAPHED BY A. ALBRIGHT MARCH, 1990

Three of the four Bathhouses [#10, #12 and #34] are identical, with the fourth [#8] being a smaller building due to its being intended for use solely by the Director of the camp. The other three (there was originally another of this type in the Echo Valley campsite; it has since been destroyed and hence is now considered a foundation) were designed for use by the entire campsite. They are single story, stone masonry buildings, similar in plan to the Staff Buildings seen above in that a wood frame and log gable roof extends out over the stone walls to form a front porch supported on log posts and a raised stone platform accessed by stone steps. Log trusses support the porch roof deck. The stone section is divided into lavatory and shower stalls.

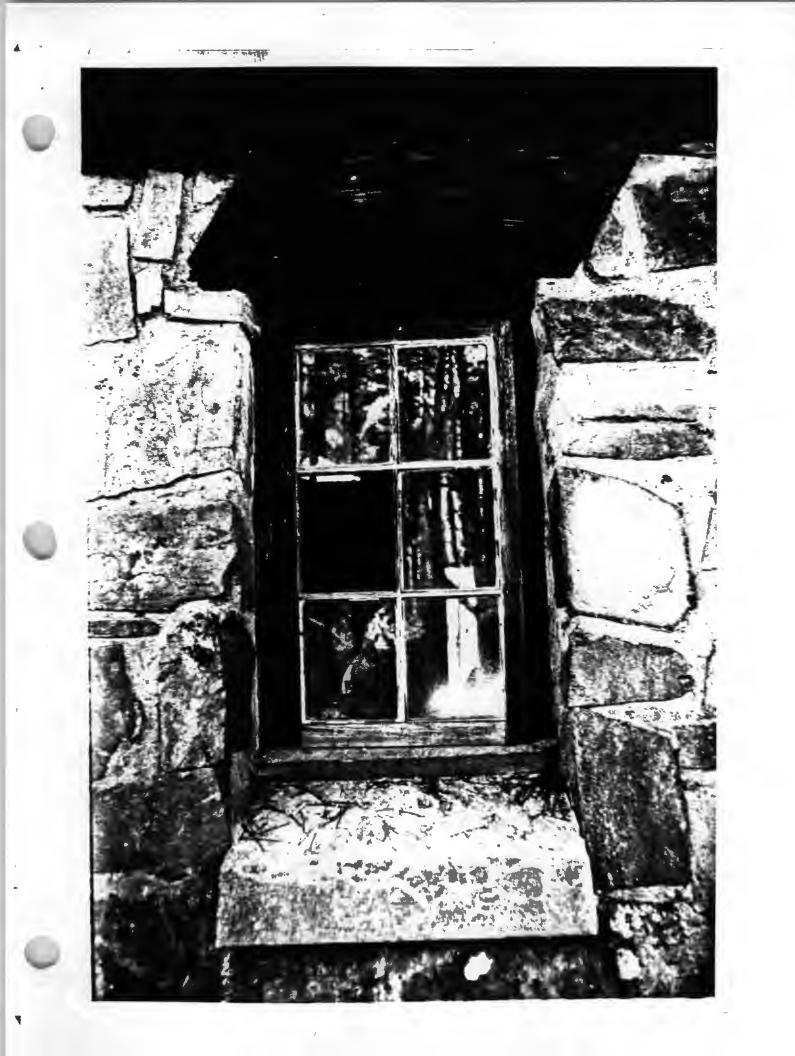
#34 NEGATIVE ON FILE AT AHPP PHOTOGRAPHED BY A. MUBRICHT BATHHOUSE WINDOW DETAIL MARCH, 1990 CAMP OUARNITA CIRL Prout CAMP HISTORIC DISTRICT PARON VIC., ARKANSAS

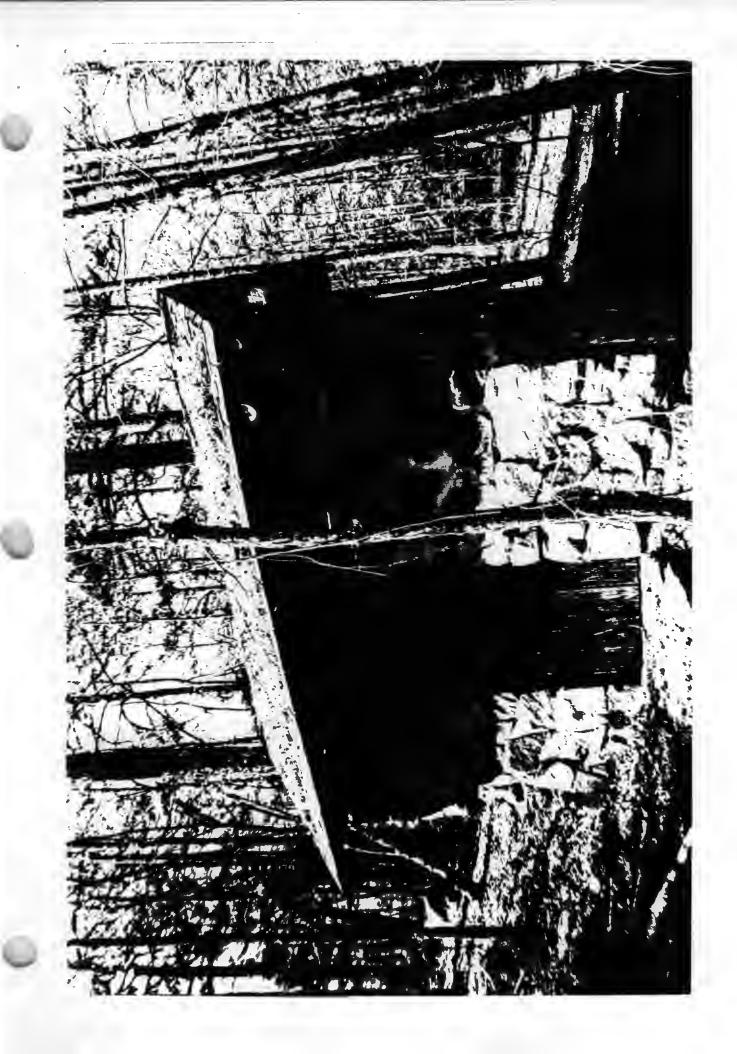
CAMP DUACHITA GIRL VOUT CAMP KISTORIC DISTRICT PARON U.R., ARRANSAS PHOTOGRAPHED &Y A. AL BRIGHT VIEW FROM NORTHEAST OF DIRECTOR'S CABIN BATHHOUSE NEGATIVE ON FILE AT AHPP MARCH, 1990

The smaller Bathhouse is also a single story in height, of stone masonry construction and covered with a gable roof. It is sited adjacent to the Director's Cabin.
