1. Name of Property		
	Girl Scout Camp Historic Di	strict
other names/site number	·	
2. Location		
street & number Forest Servic	re Road #152	not for publication N/A
city, town Paron		X vicinity
state Arkansas code	AR county Perry	code AR 105 zip code 72122

SUMMARY

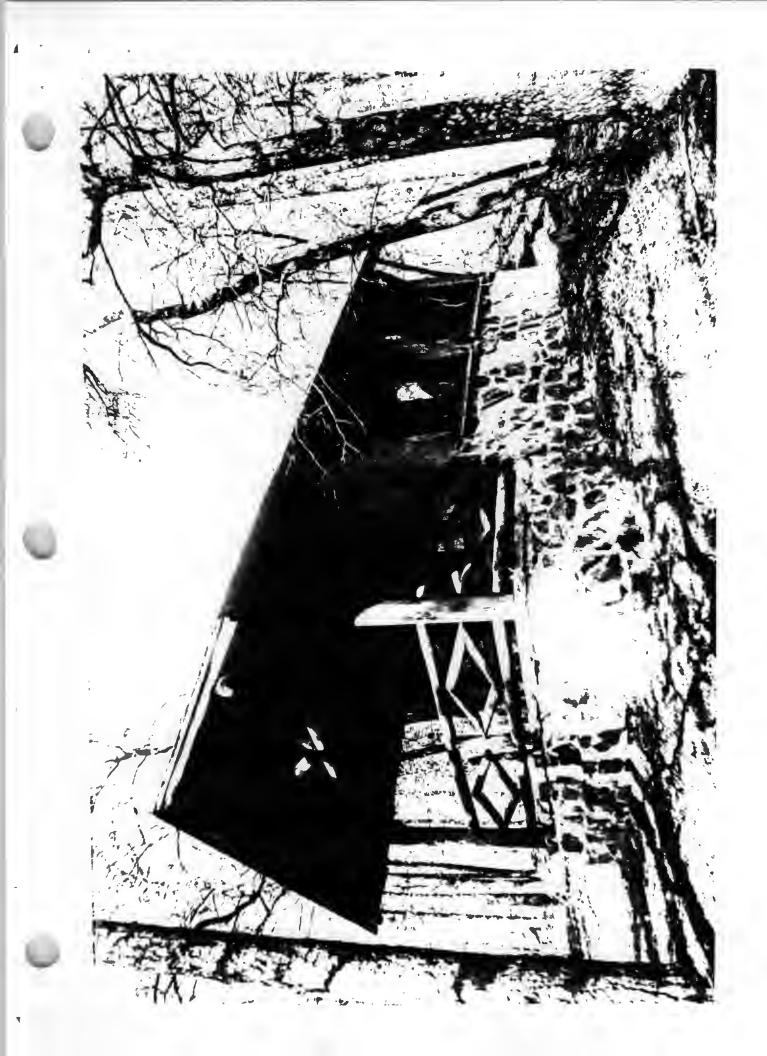
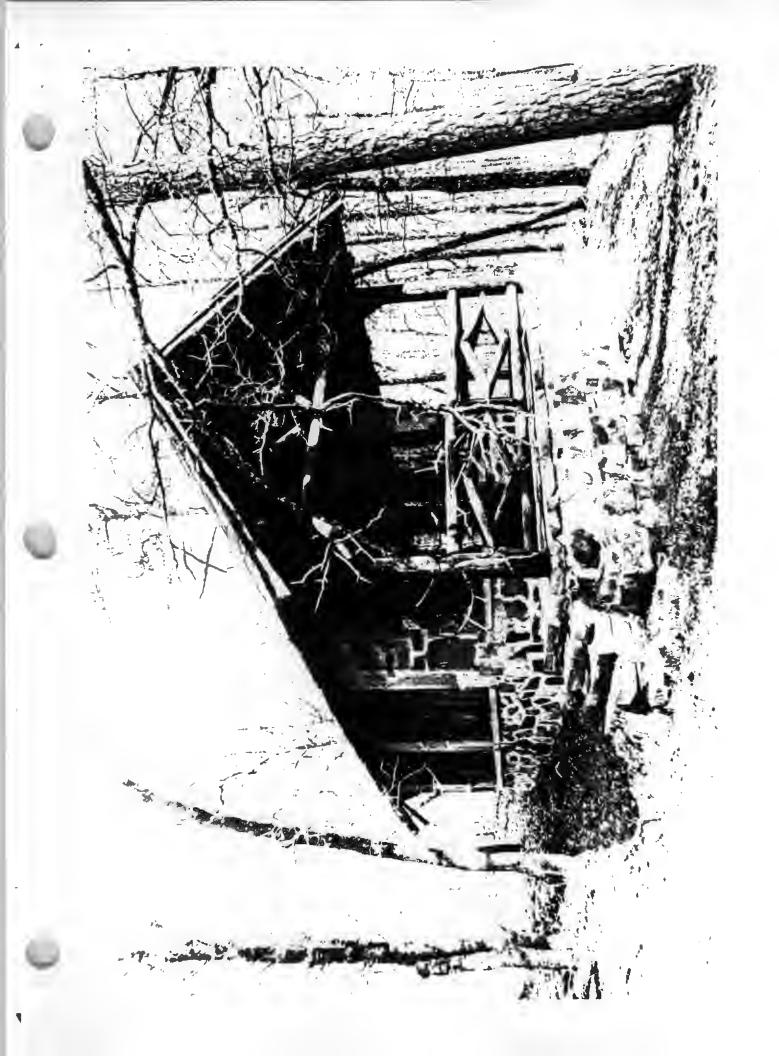
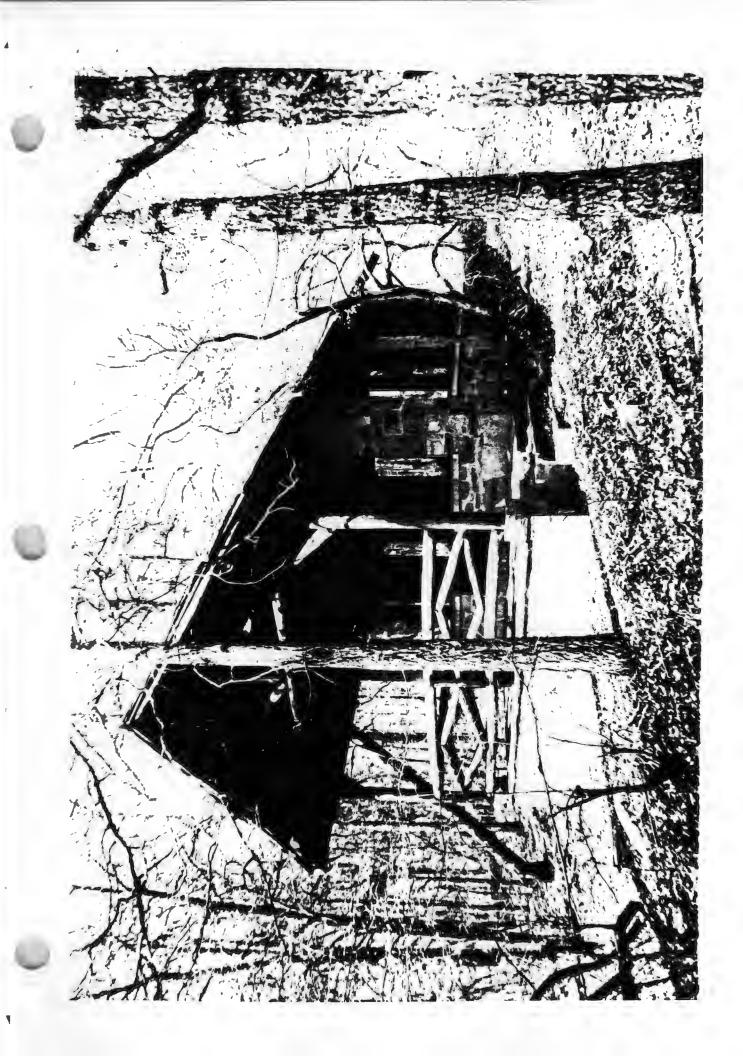
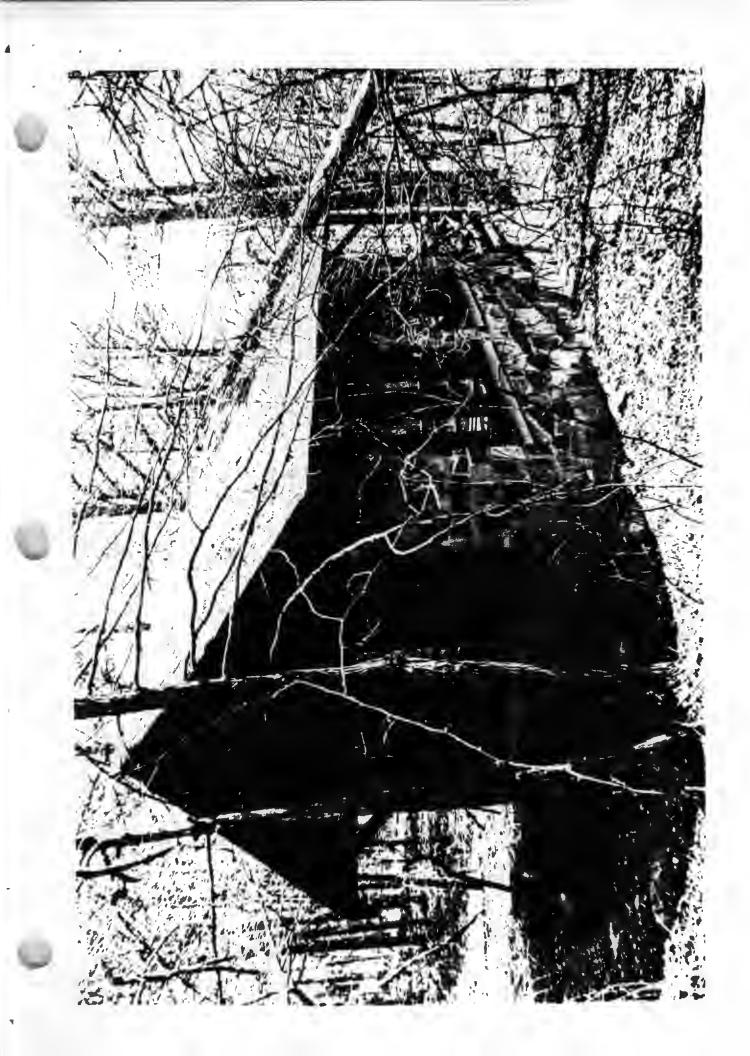
CAMP OUNDANTA GIRL STOUT CHMP KLISTOPIC DISTRICT NEGATIVE ON FILE AT AHPP VIEW OF CHEN FROM SOUTHWEST PHOTOGRAPHED BY A. ALBRIGHT MARCH, 1990 # 35 PARON VIC., ARXANSAS

CAMP OUNCHITA GIRL SCUT PANIP HISTORIC DISTRICT PHOTOGRAPHED BY A. ALBRICHT VIEW OF COON FROM NORTHWEST NEGATIVE ON FILE AT AHOP PARON VIC., ARKANSAS MARCH, 1990 *35

NEGATIVE ON FILE AT ANPP VIEW OF CABIN FROM NORTHEAST PARON UK, AREANSAS PHOTOGRAPHED BY A. ALBRIGHT MARCH, 1990 CAMP OUNCHITA CIPA SPORT CAMP DISTRICT # 39

39 MARCH, 1990 NEGATIVE ON FILE AT AHPP VIEW OF CABIN FROM SOUTHWEST PHOTOGRAPHED BY A. ALBRIGHT PARON LIC., ARKANSAS CAMP OLARNITA GIRL Scout CAMP MISTORIC DISTRICT ٦

The twenty-one of the twenty-two extant Cabins [#13, #14, #15, #16, #17, #18, #19, #20, #21, #24, #28, #29, #30, #31, #32, #35, #36, #38, #39, #41 and #42] are identical, with the sole exception being the Director's Cabin [#9], which was constructed as an enclosed year-round residence with a fireplace and chimney. Each of the other twenty-one cabins (called "tent platforms" on the accompanying sketch map) is a single story, stone masonry, screened shelter with a wood frame and log gable roof that projects out over the front elevation, forming a front porch. The porch roof is supported by log posts resting on a raised stone platform; the posts are connected by a log balustrade composed of logs set in a diamond-shaped decorative pattern between horizontal log rails. The porch is accessed from the side

via stone steps and features log trusses in the roof. The single pen inside the stone walls is unornamented and consists only of a stone floor, the screened walls and the roof. Some of the cabins are named, the name plate appearing above the front door.

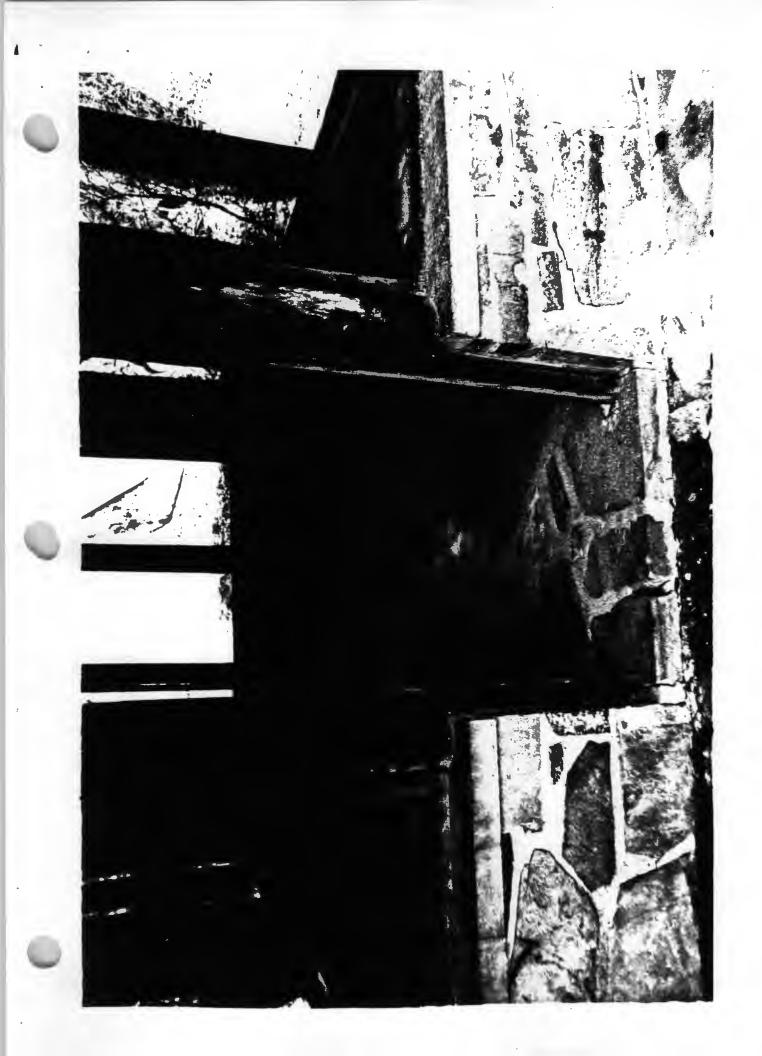
CAMP OUNCHITA CIRL SPOUT CAMP HISTORIC DISTRICT PHOTOGRAPHED BY A. ALBRICHT MARCH, 1990 PARON Vic., ARKANSAS VIEW FROM EAST OF CABIN FLOOR STONEWORK NEGATIVE ON FILE AT AHPP \$ S &

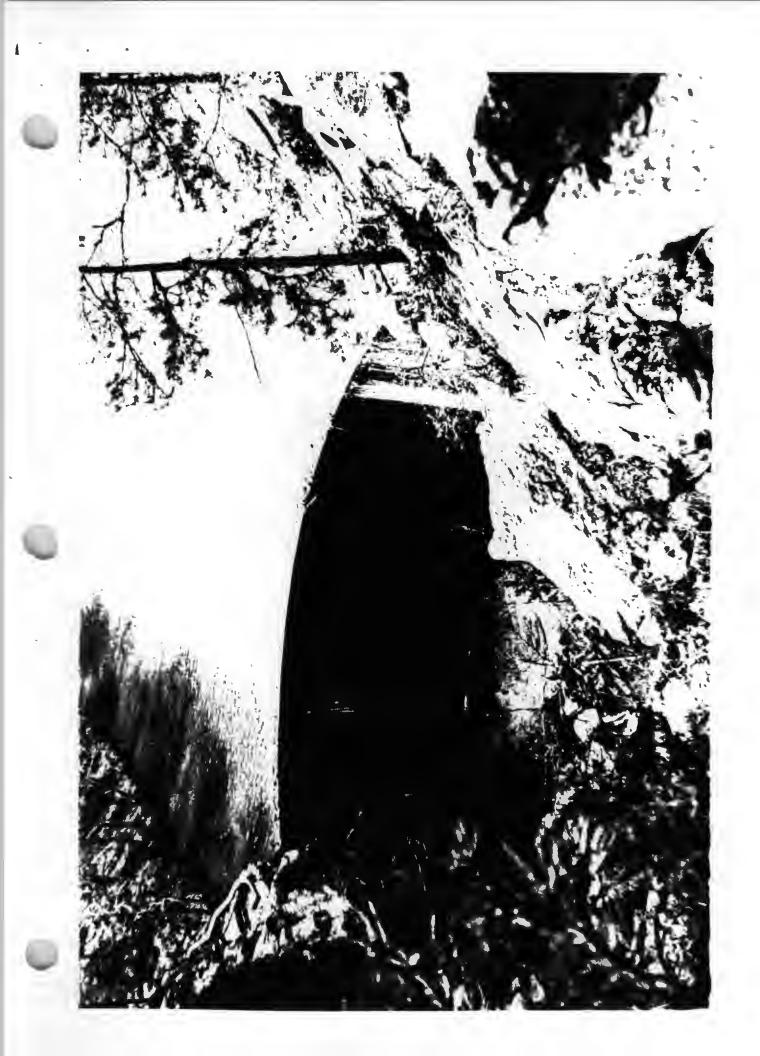
CAMP OUACHITA GIAL STOUT CAMP HISTORIC DISTRICT PARON VIL, ARKANSAS PHOTOGRAPHED BY A. ALBRIGHT NEGATIVE ON THE AT AHOP VIEN FROM NORTHEAST OF DAM # 49 MARCH, 1990

The Structures include the original concrete dam [#49] (fifty feet in height) at the northern end of Lake Sylvia, the two square, concrete water tanks [#47 and #48] located on a rise above the lake near the Director's Cabin and the stone masonry pumphouse [#50] located near the northern edge of the lake, below the water tanks.

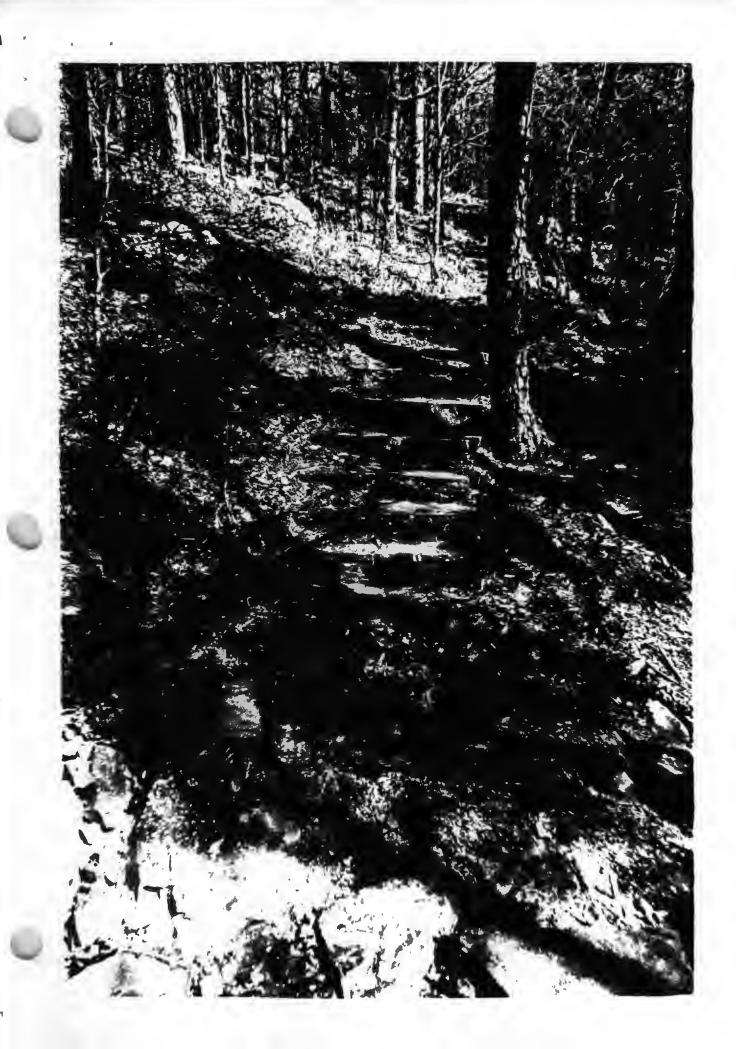
HISTORIC DISTRICT PANEN VIE, ARKANSAS DEGTOGRAPHED BY A. ALBRICHT MARCH, 1990 NEGRTIVE ON THE AT ANPP VIEW OF TRALL STEPS CAMP OUNCHITA HATCORE Distant Clier Jost Comp

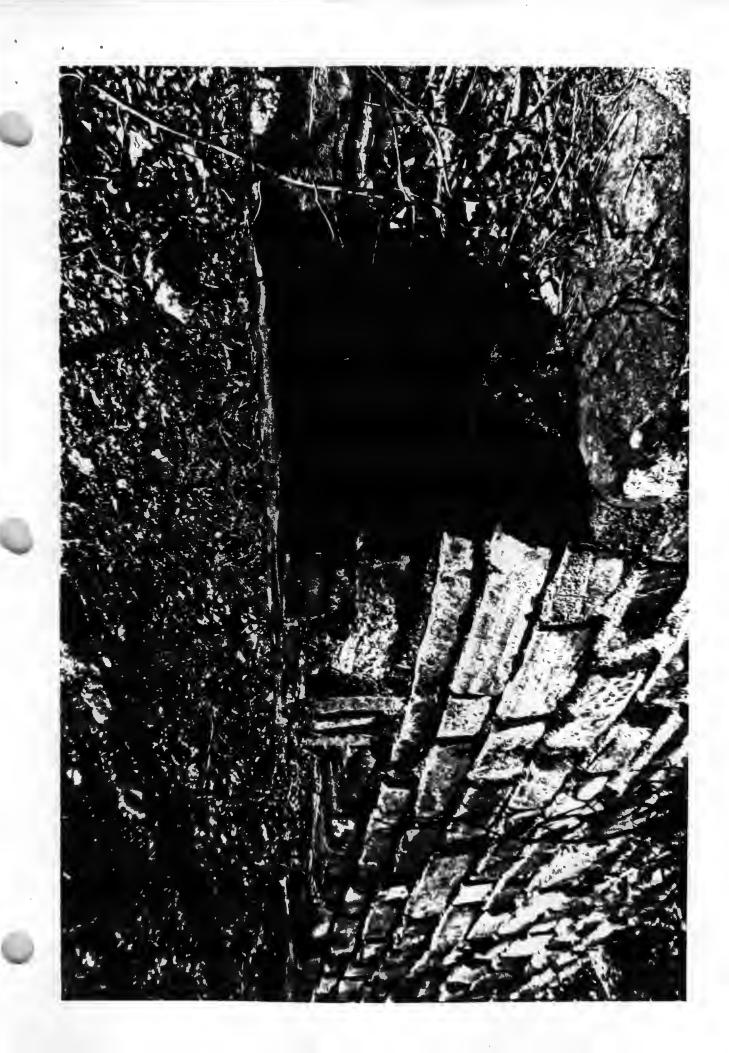
NEARTILE ON FILE AT AHPP VIEW OF BONE RETOINING WALL MARCH, 1990 PROTOCRAFNED BY A. AL BRIGHT CAMP OUNCHITA QUEL SPOUT PEMP HISTORIC DISTRICT PARON VIE, ARKANSAS Į

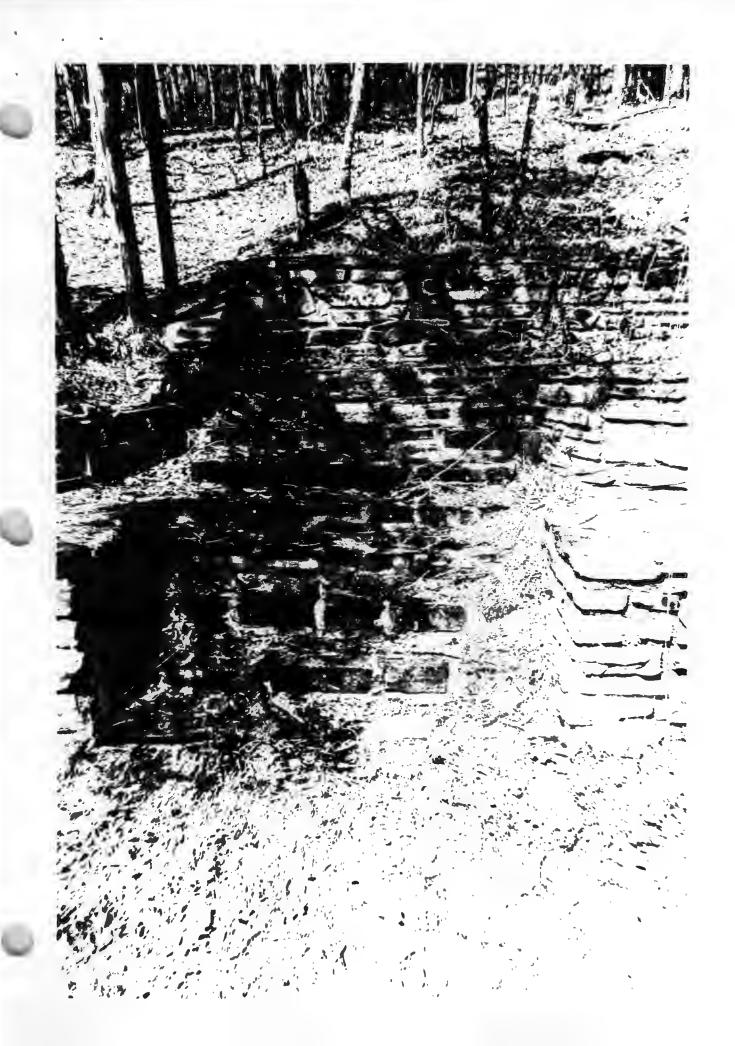
MARREN, 1990 NEGATIVE ON TILE AT AHPP VIEW OF STONE STEPS PHOTOGRAPHED BY A. ALBRICHT AND OUACHITA CIRL SCOLT CAMP HISTORIC DISTRICT PARON vie, ARKANSAS ٩

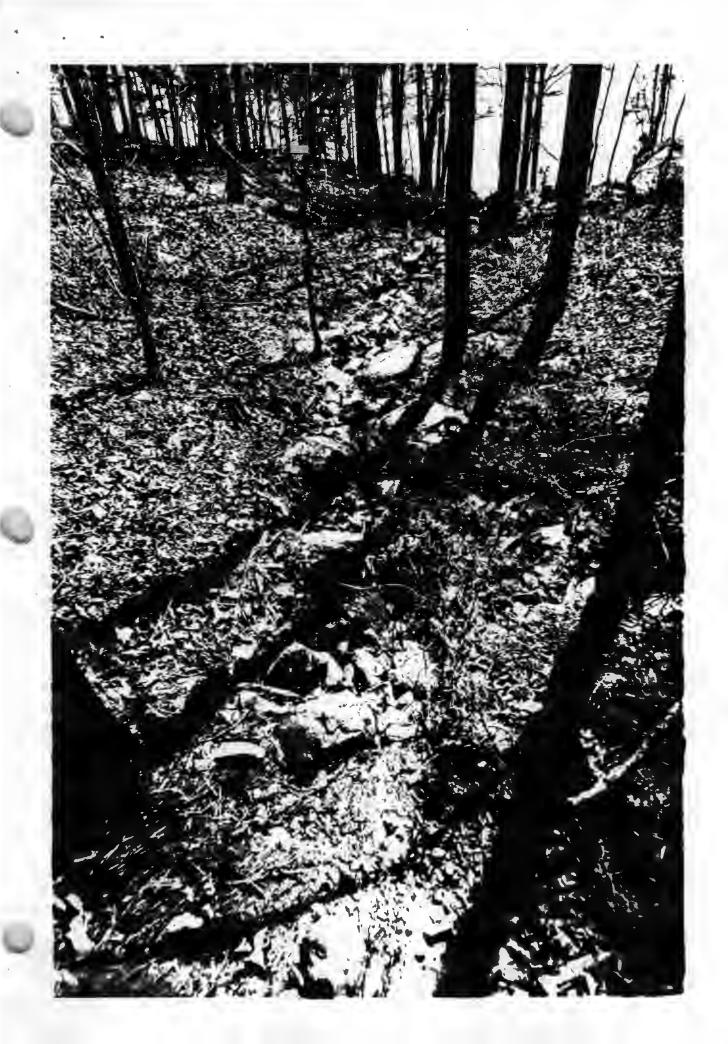
VIEW OF TRAIL CONSTRUCTION NEGATIVE ON FILE AT ANPP CAMP OUNCHITA GIRL Scout CAMP HISTORIC STRICT PARON VIC., ARKANSAS PHOTOGRAPHED BY A. ALBRICHT MARCH, 1990

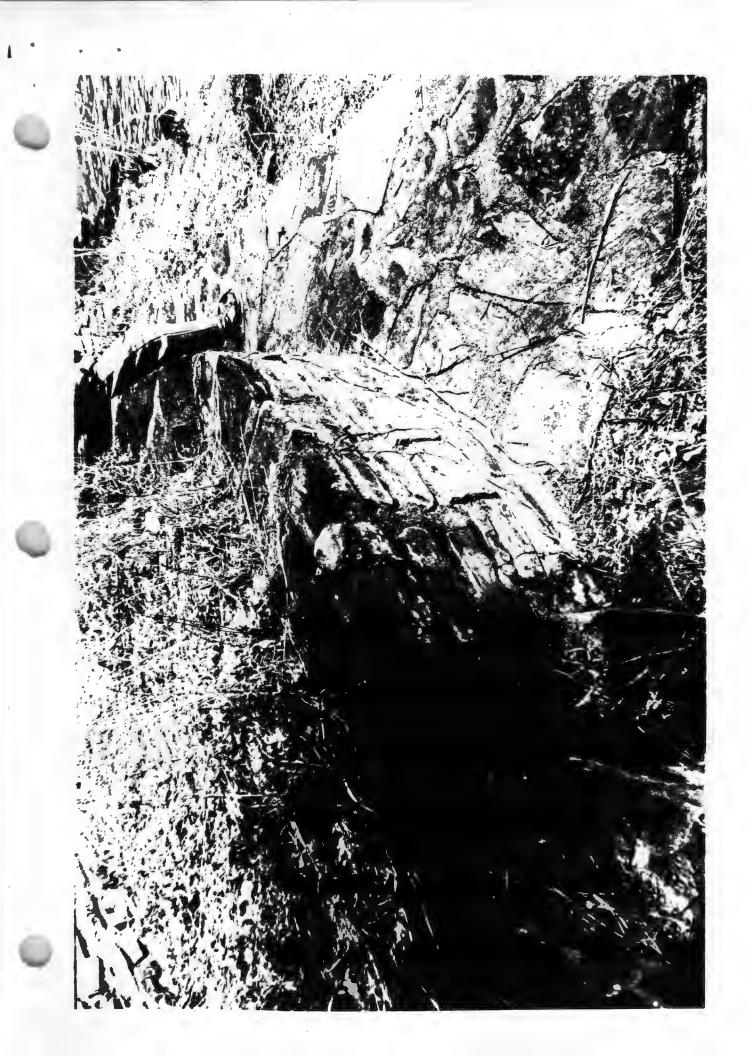
CAMP OUNENITA GIRL SCOT CAMP HISTORIE DISTRICT PARON UN, ARKANSAS PHOTO GRAPHED BY A. ALBRIGHT MUMICH, 1990 NEGATIVE ON FILE AT ANPO DETAIL OF RETAINING WALL BEHIND BOAT HOUSE

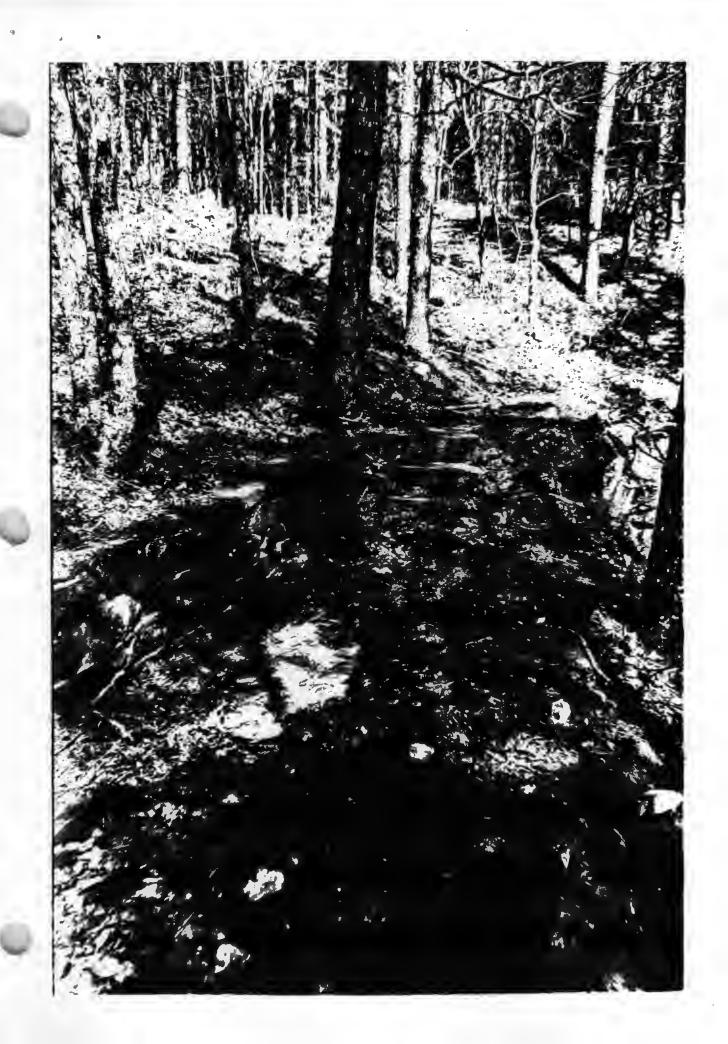
MARCH, 1990 VIEW OF TRAIL STEPS AND STURE WALLS NEGATIVE ON FULE AT AHPP PHOTOGRAPHED BY A. AL BRIGHT PARON VIC., MERANSAS CAMP OUNCHITA GIRL SPOUT CAMP HISTORIC DISTRICT

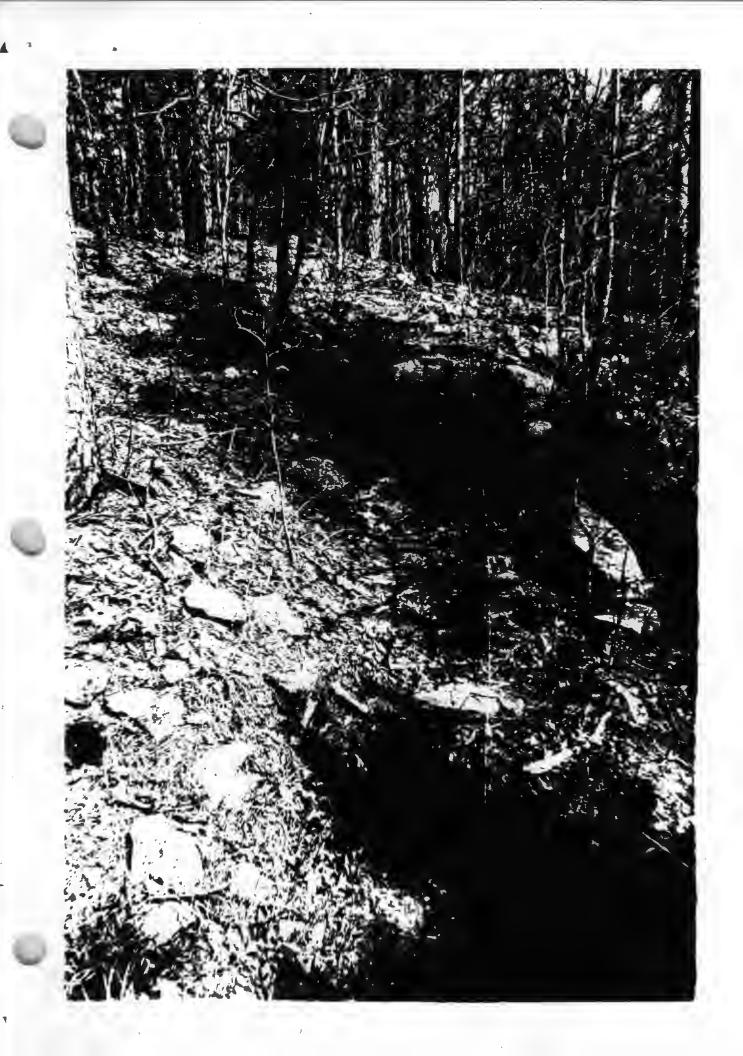
NEGATIVE ON THE AT AHPP VIEW OF TRAIL CONSTRUCTION PARON VIC., ARKANSAS PHOIDGRAPHED & A. ALBRICHT MARCH, 1990
