NATIONAL REGISTER OF HISTORIC PLACES REGISTRATION FORM
1. Name of Property
historic name: Leslie-Rolen House
other name/site number: <u>SE 0263</u>
2. Location street & number: Eastern corner of Cherry and High Streets
not for publication: N/A
city/town: Leslie vicinity: N/A
state: AR county: Searcy code: AR 129 zip code: 72645
3. Classification Ownership of Property: Private
Category of Property: Building
Number of Resources within Property:
Contributing Noncontributing
Number of contributing resources previously listed in the National Register: N/A

The Leslie-Rolen House is a one-and-a-half story, wood-frame residence constructed in 1907 in the Plain Traditional style. Essentially square in plan, the house is covered by a hipped roof with three projecting cross gables and three gabled dormers. The exterior remains basically intact; however, the interior has been altered somewhat. There is one associated outbuilding, a gable-roof storage shed, located near the eastern corner of the house. A deteriorated concrete retaining wall on two sides of the house is also included in the nomination. Located at the eastern corner of High and Cherry Streets in Leslie, the Leslie-Rolen House is

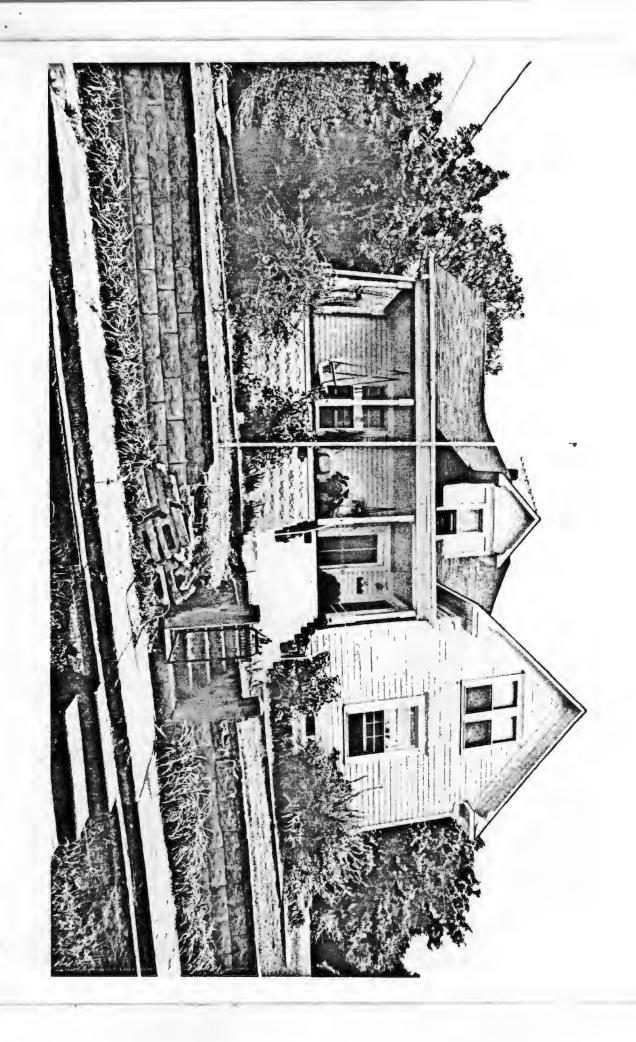
Leslie-Rolen House Searcy G., Ar Kansas Photograph by Todd Ferguson August 1991 Wegative on file at AHPP View of the Front, Orsouthwestern, elevation

The front, or southwestern, elevation consists of a projecting gable-end bay to the south and a shed-roofed porch along the remainder of this elevation. A large eighteen-over-one double-hung window dominated the first-story of the projecting gable-end bay. In the gable end, a pair of conventional one-over-one double-hung windows reside between the jigsawn ornamented cornice returns. Due to the slope of the landscape, the porch is several feet above ground and is accessed by concrete steps. The porch roof is supported by five turned-spindle posts, another sign of Queen Anne/Folk Victorian-style influence. Underneath the porch, there are two single-leaf wood doors with one entering into the projecting gable room. An eighteen-over-one window provides the only fenestration of that wall area. Above the shed roof, an inset gabled dormer with a one-over-one window projects from the roofline. The dormer duplicates the cornice return trim found on the larger projecting gable bay and is otherwise similar except on a smaller scale.

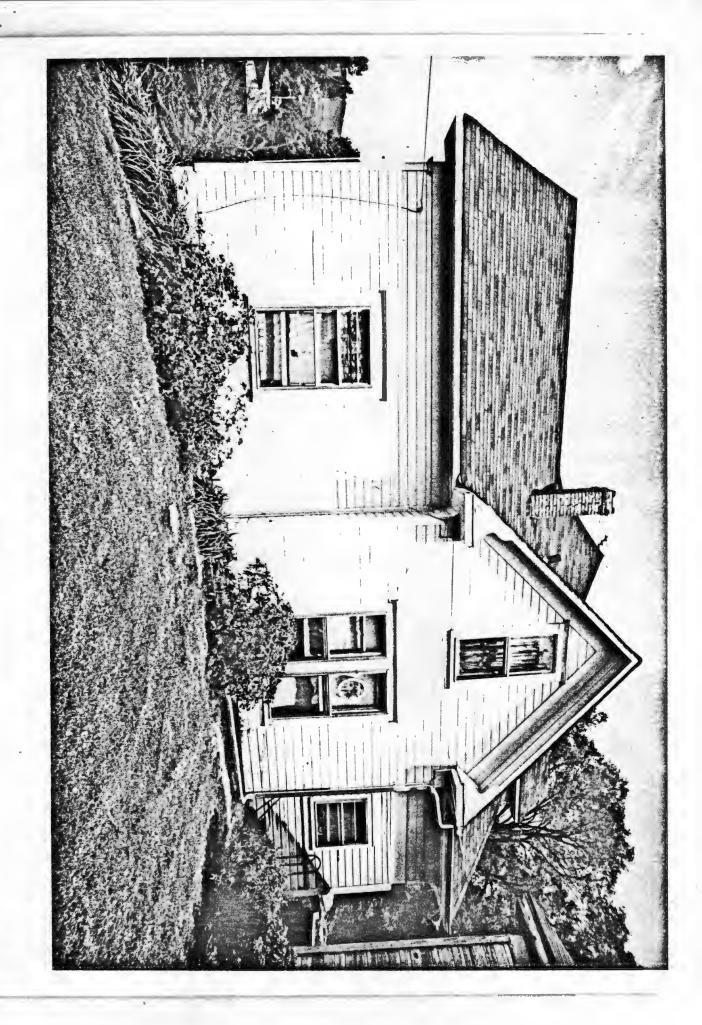
Leslie-Rolen House Searcy Co., Arkansas Photograph by Fold Ferguson Angust, 1991 Legative on File at AHPP View from the southeastern elevation

A projecting-gable bay identical to the one on the northeastern elevation is placed to the east of center on the southeastern elevation. To the east of this bay is the short side wall of the enclosed inset porch. A small aluminum-frame two-over-two window has been installed here. The longer room to the north of the projecting-gable bay is lighted by a large one-over-one window.

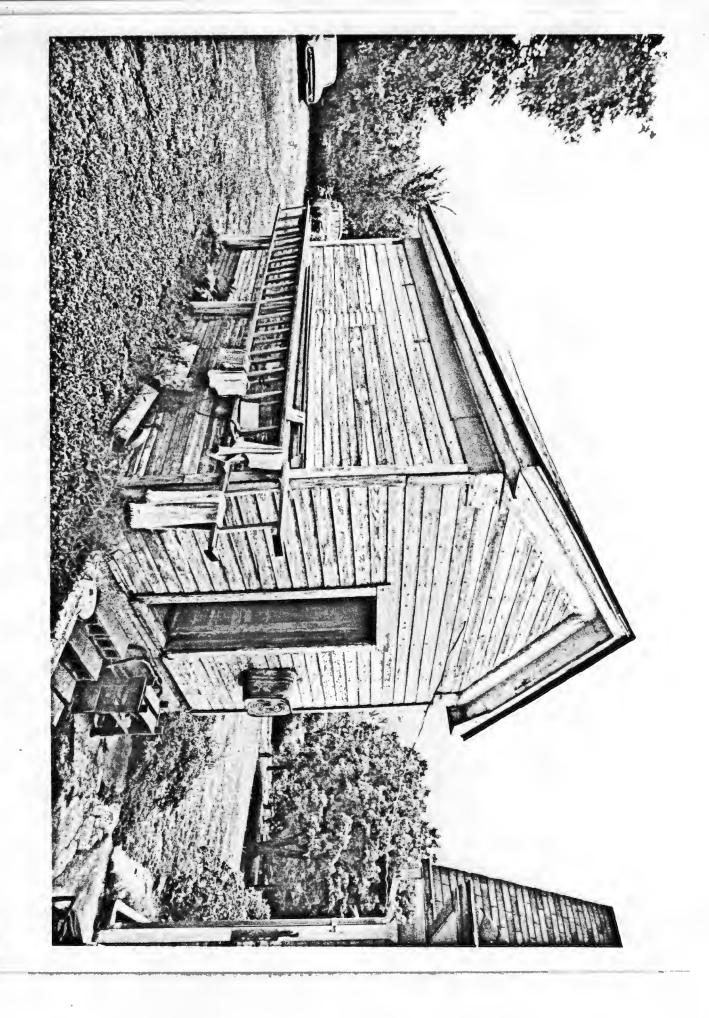
Searcy Co., Arkonsas
Searcy Co., Arkonsas
Photograph by Todd Ferguson
August 1991
Vesative on tile at AHPP
View of outbuilding from the north

There is one contributing outbuilding located near the eastern corner of the house. that may have originally been used as a smokehouse. Clad with drop siding (and some false-bevel novelty siding on the northeast elevation) and covered by a gable roof, the outbuilding presents a dignified appearance through the use of enclosed eaves and a wide frieze band with returns.
